**“Joint Management of Urban Wetland Areas in border region Latvia-Lithuania”  
Urb-Area Nr.LLI-472**

**Final report on monitoring of urban wetlands in Daugavpils and Anykščiai**

**“Progress in restoring green infrastructure in urban wetlands, effectiveness of joint cross-border management of urban wetlands and mitigation of environmental risks”**

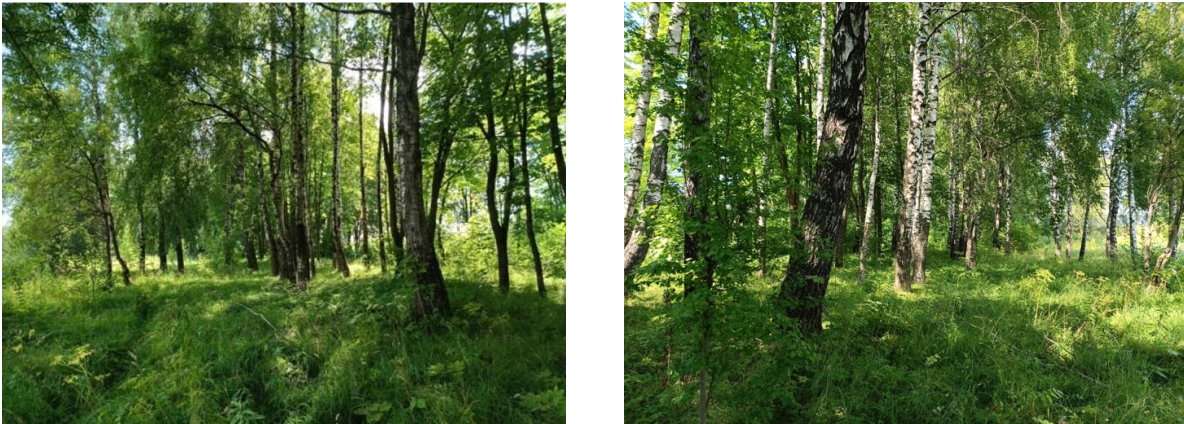
The project involved cutting and removal of overgrown shoots in the tree stand along Daugavas Street (Figure 1), covering a total area of 0.51 ha (Figures 2 and 3). Prior to the management measures, the area was densely overgrown with tree and shrub shoots (including expansive and invasive species). As a result of the implemented management measures, lighting conditions on the vegetation layer have improved, which will contribute to an increase in vascular plant diversity. To ensure the long-term effectiveness of the implemented management measures, mowing of regrowth should be repeated at least once every 3-5 years. It is mandatory to remove the cut material from the site.

*Figures 2 and 3. Birch stand along Daugavas Street, where shoot mowing has been implemented (Photo: U. Valainis)*

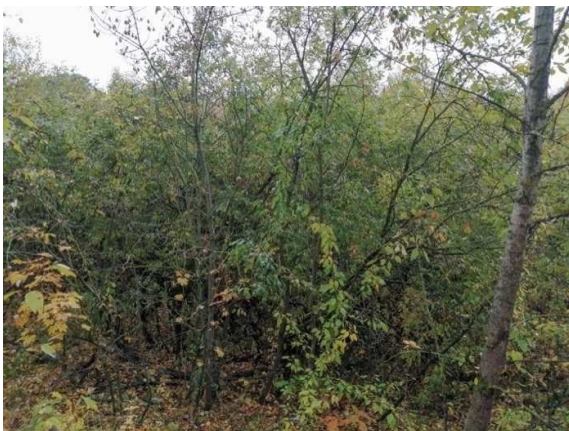
*Figure 4. Wetland area adjacent to Esplanade Park before shrub thinning (Photo: U. Valainis)*

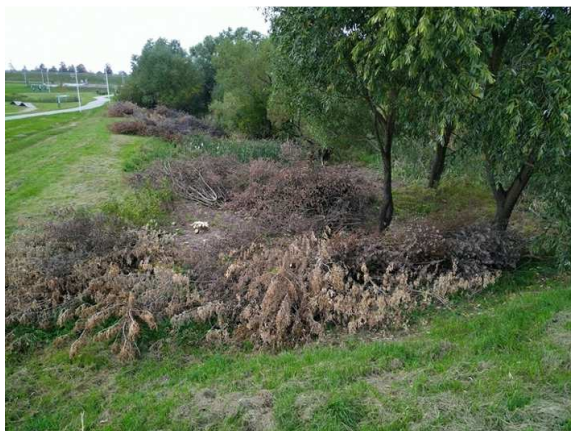
*Figure 5. Wetland area adjacent to Esplanade Park during implementation of management measures (Photo: U. Valainis)*

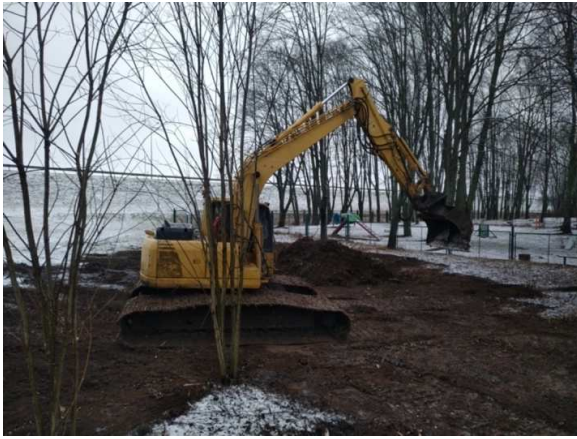
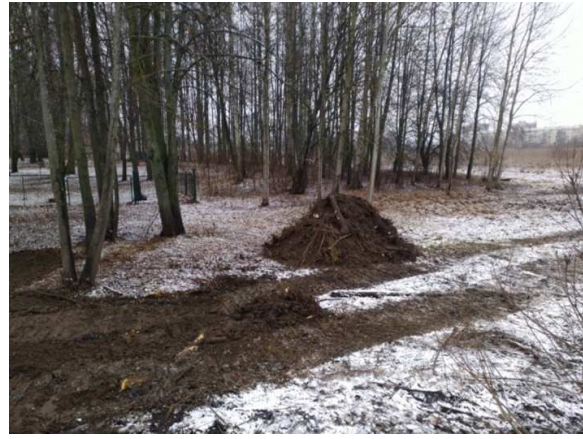
*Figures 6 and 7. Where tree stumps could make future management difficult, tree stumps and roots are removed (Photo: U. Valainis)*

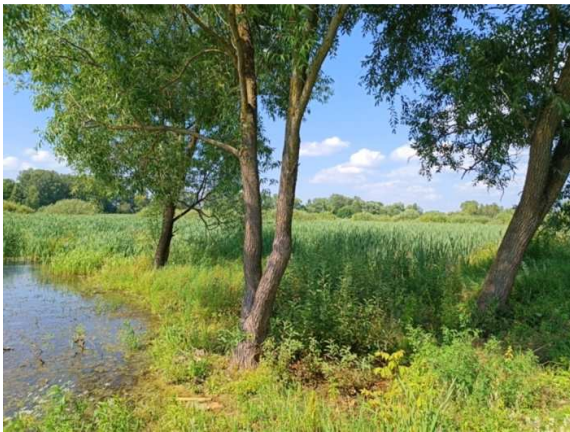
In the wetland areas of the grassland, individual trees and shrubs have been left in place during the implementation of management measures (Figures 8 and 9), as this increases the overall species diversity of the grassland. A small amount of shrubs and trees in a meadow increases the number of

*Figure 8. Biologically older trees are preserved during clearing overgrowth in densely vegetated areas. (Photo: U. Valainis)*

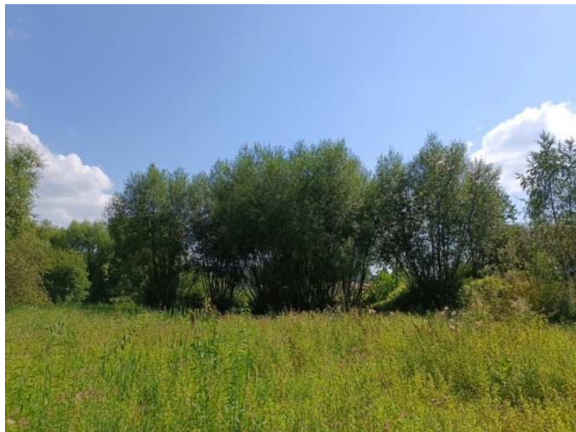
*Figure 9. The most scenic groups of shrubs were primarily preserved during shrub thinning (Photo: U. Valainis)*

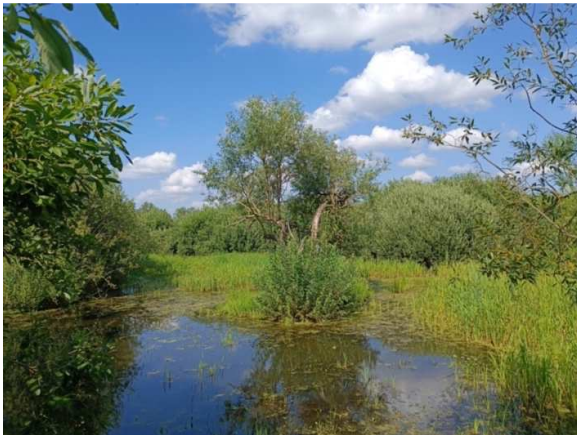
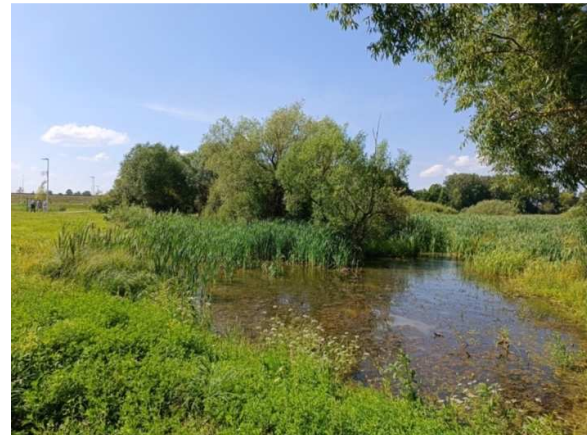
Management measures payed particular attention to spring-flooded areas, which are usually characterised by specific flora and fauna. In the Esplanade Wetland, before the implementation of management measures, the densely vegetated overflow areas had become of low biodiversity value as a result of shading. The clearing of shrubs primarily cleared low-lying areas of vegetation (Figures 10 and 11), which will increase light and make the open water areas warmer and more suitable for many aquatic organisms in spring. The areas cleared of shrubs have increased the amount of open water and riparian areas used by birds for resting and feeding, and have had a positive effect on the area of suitable nesting slopes (the reduction in shrub and tree cover increases the proportion of areas suitable for nesting water birds) (Figures 14 and 15). The mosaic location of maintained trees and shrubs along the S edge of the site reduces the impact of human disturbance.

*Figures 10 and 11. Bush clearance was primarily performed in spring flooded areas (Photo: U. Valainis)*

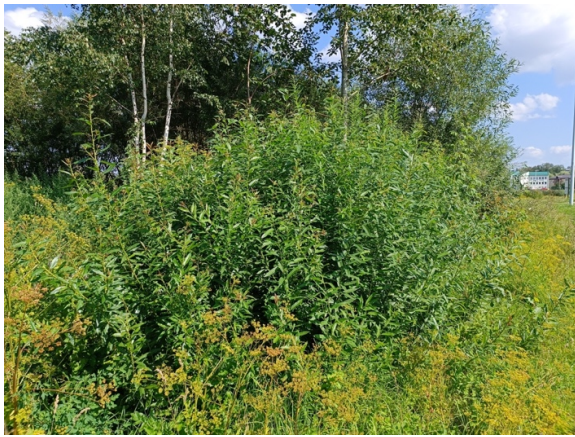
*Figure 12. Dense shoots in the first year after management in cleared areas (Photo: U. Valainis)*

In the first year after the management measures, tree and shrub shoots have grown back. In the first years after the implementation of shrub and tree thinning, it is necessary to ensure the clearing of the regrowth (Figure 12) at least once every 3-5 years. It is recommended to control sprouts on stumps by stump and root pruning.

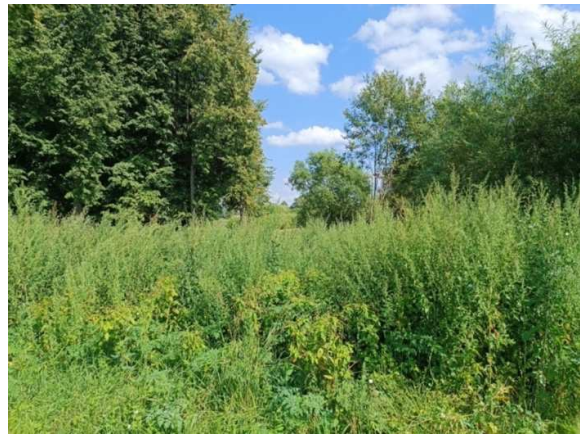
*Figure 13. Distribution of expansive plant species in managed areas (Photo: U. Valainis)*

In areas of grassland where shrub and tree thinning has been carried out, mowing should be carried out at least once a year to ensure the long-term effectiveness of the management measures implemented. It is mandatory to remove the mowed hay from the site in order to reduce soil eutrophication. Mowing at least once a year in the first years after management is necessary to reduce the spread of expansive species in the remaining area cleared of vegetation (Figure 13).

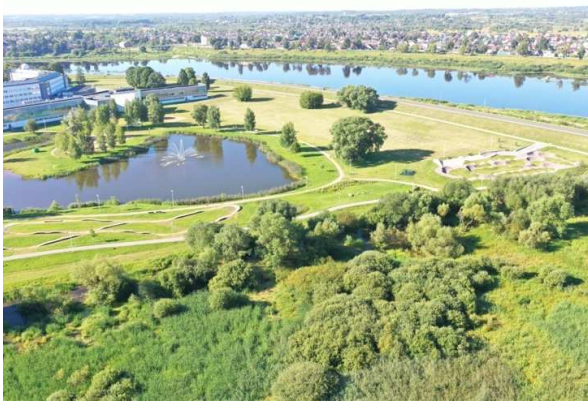
*Figure 14. S part of the Esplanade area after completion of the shrub cover fragmentation (Photo: M. Nīcīsis)*

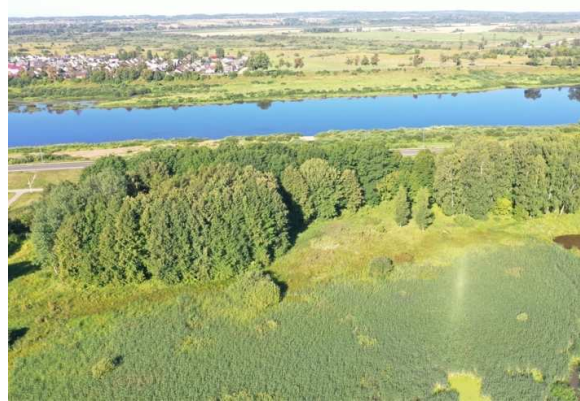
*Figure 15. W part of Esplanade area after completion of shrub cover fragmentation (Photo: M. Nīcīsis)*

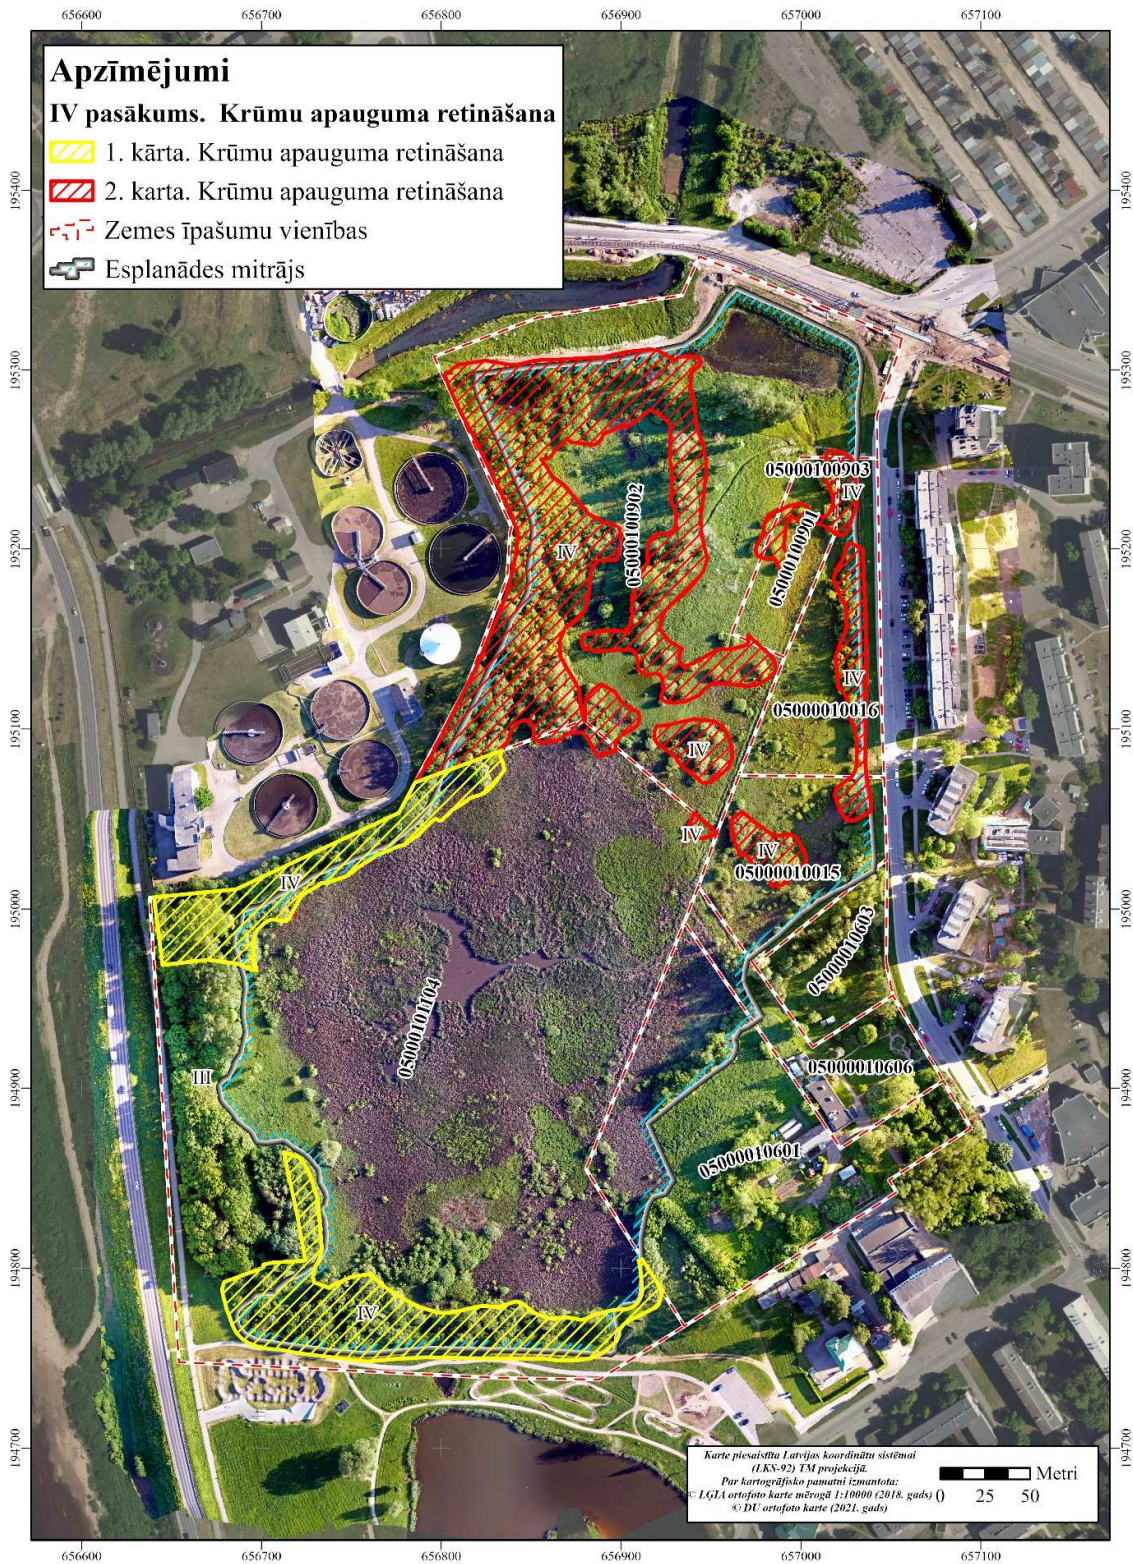
Figure 16. Shrub cover thinning sites that are already implemented (Phase 1) and planned (Phase 2)

In Phase 2 of the management measures, thinning of trees and shrubs is also recommended in other land units within the Esplanade Wetland (Figure 16) where rapid overgrowth with shrubs has been observed.

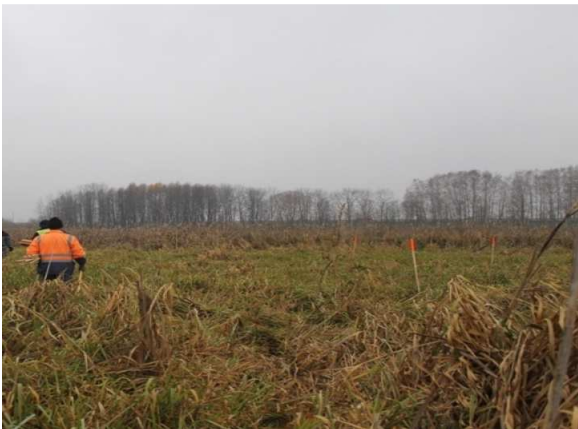
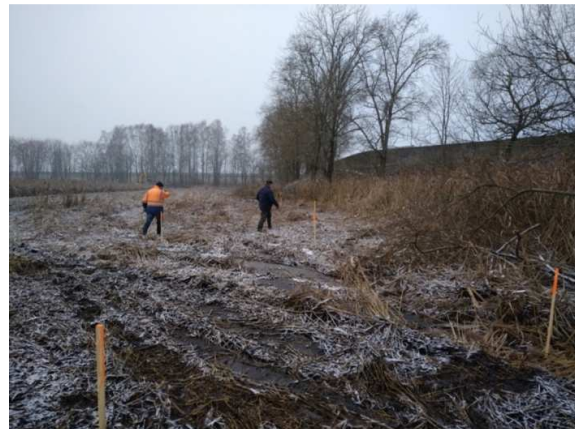
*Figures 17 and 18. The boundaries of the planned water bodies are marked in the field with painted stakes (Photo: U. Valainis)*

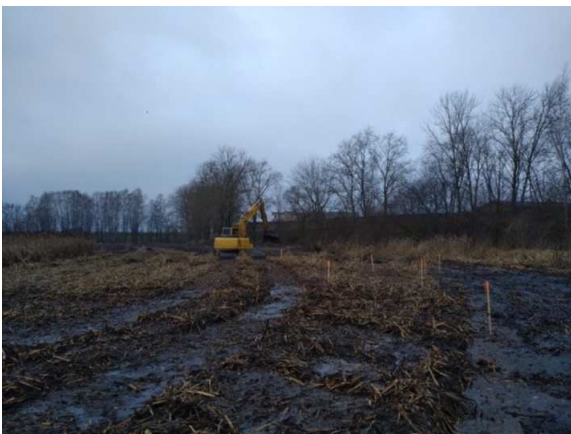
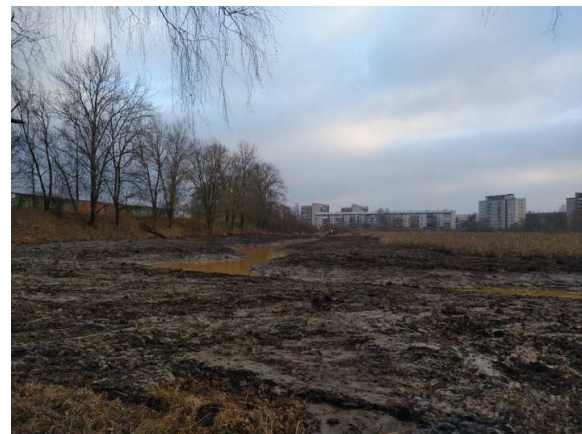
The works planning process included detailed planning of the works to be carried out in Phase 1, defining the desired parameters of each water body to be excavated and the desired locations of the excavated subsoil to be levelled. Prior to the start of the works, the natural experts involved in the project marked each planned water body in the field by driving stakes into the contour lines of the planned ponds (Figures 17 and 18). According to the boundaries put in nature, aquatic plants, silt and soil material were excavated and levelled (Figures 19 and 20).

*Figures 19 and 20. Excavation and levelling of aquatic vegetation, silt and soil material performed in accordance with boundaries put in nature (Photo: U. Valainis)*

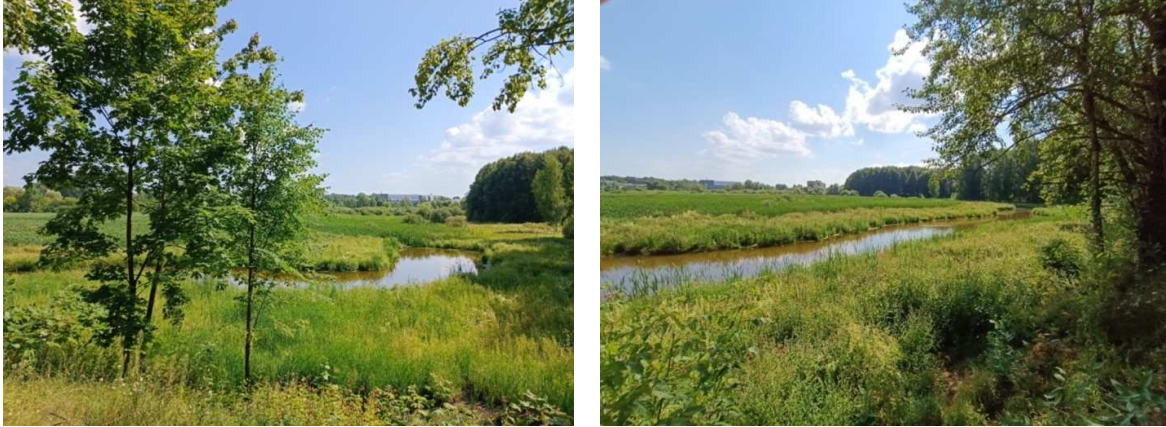
The shapes of the ponds are designed in curved lines to resemble river meanders, thus blending more naturally into the landscape (Figures 21 and 22).

*Figures 21 and 22. The ponds created would resemble river meanders, thus blending more naturally into the landscape (Photo: U. Valainis)*

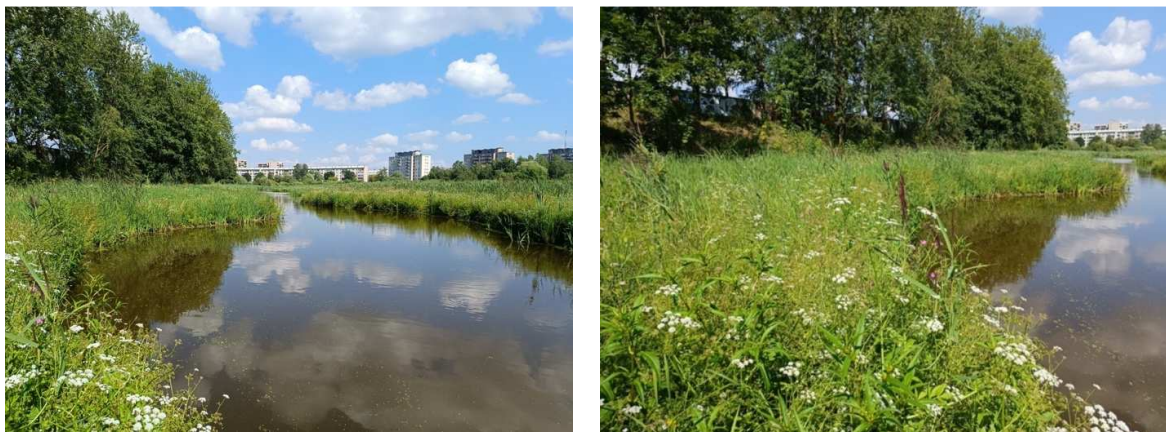
The performed management measures have had a positive impact on the vegetation of the Esplanade Wetland. Prior to the management measures, the area was dominated by monodominant stands of bulrush and reeds, which prevented the spread of other less competitive vascular plant species. The removal of bulrush and reeds from the pond banks, as well as the removal of trees and shrubs, contributed to a change in the composition of vascular plants, resulting in the spread of myrtle-loving species in the first year after the management measures, which occupied the newly created open niche on the pond banks. In the first year after the implementation of the management measures (Figures 25 and 26), the banks of the newly created ponds and canals showed a relatively poor diversity of vascular plants, but there was also no clear dominance of expansive species (Figures 23 and 24).

*Figures 23 un 24. In the first year after the implementation of the management measures, the vegetation structure around the excavated ponds has already improved (Photo: U. Valainis)*

Following the implementation of the management measures, favourable growing conditions have also been created for a number of invasive species that were present in the area before the management measures were implemented, but in relatively small numbers. In order to maintain biodiversity, limit the spread of invasive species and limit the overgrowth of shrubs, further management of the site is required, with mowing at least once a season before the seeds of invasive species have matured.

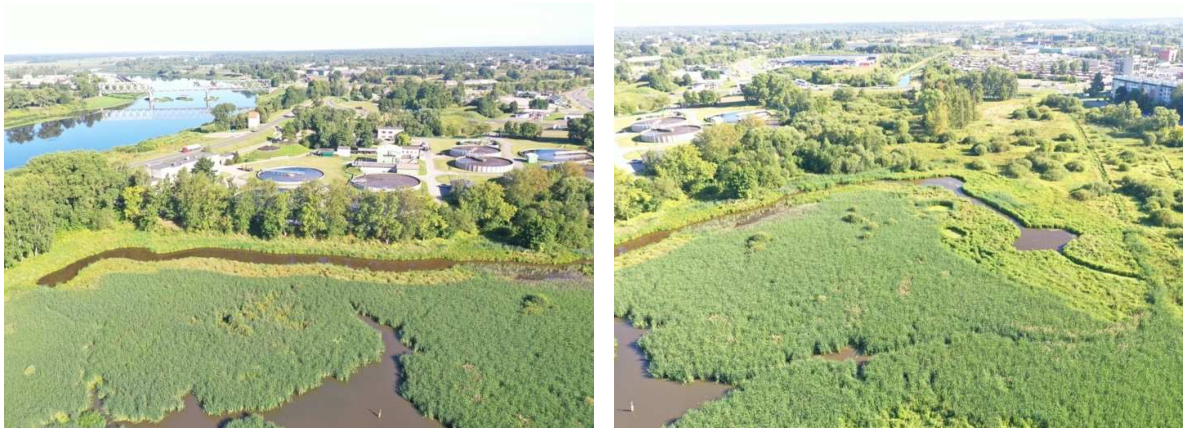
Figures 25 and 26. Bird's eye view of the pond/canal system created in the Esplanade Wetland (Photo: M. Nitcis)

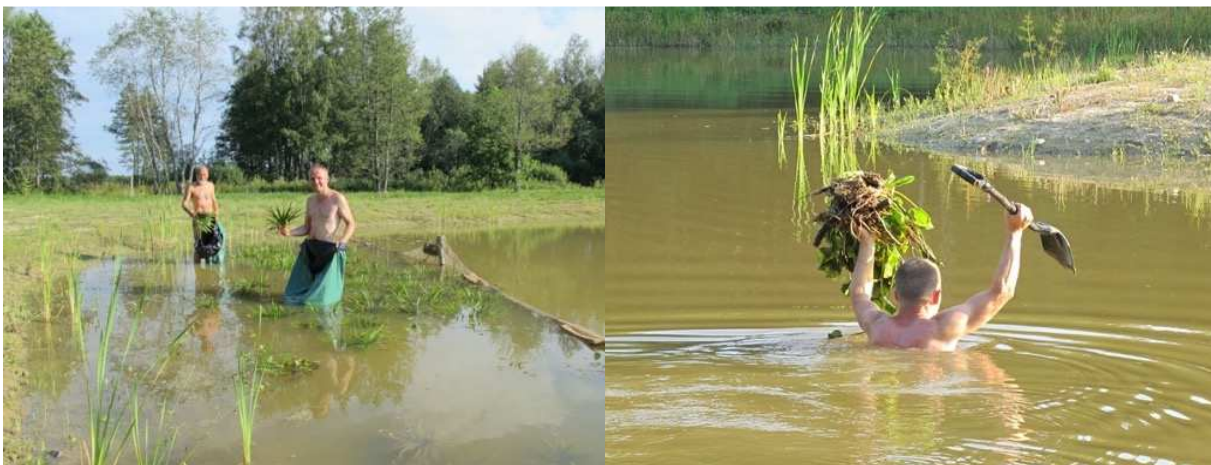
Figures 27 and 28. Activities of planting aquatic plants to enhance aquatic invertebrate diversity (Photo from archive of M. Kalniņš)

Over time (2-3 years), as underwater vegetation develops, the value of the excavated pond/canal for different animal species will only increase. To accelerate this process, it is recommended to plant aquatic plant species (Figures 27 and 28) in the excavated pond/canal, which form different vegetation structures that are in turn used by different groups of organisms. The primary species to be introduced into the water body are the water soldiers *Stratiotes aloides*, the yellow water-lily *Nuphar lutea* and the common frogbit *Hydrocharis morsus-ranae*.

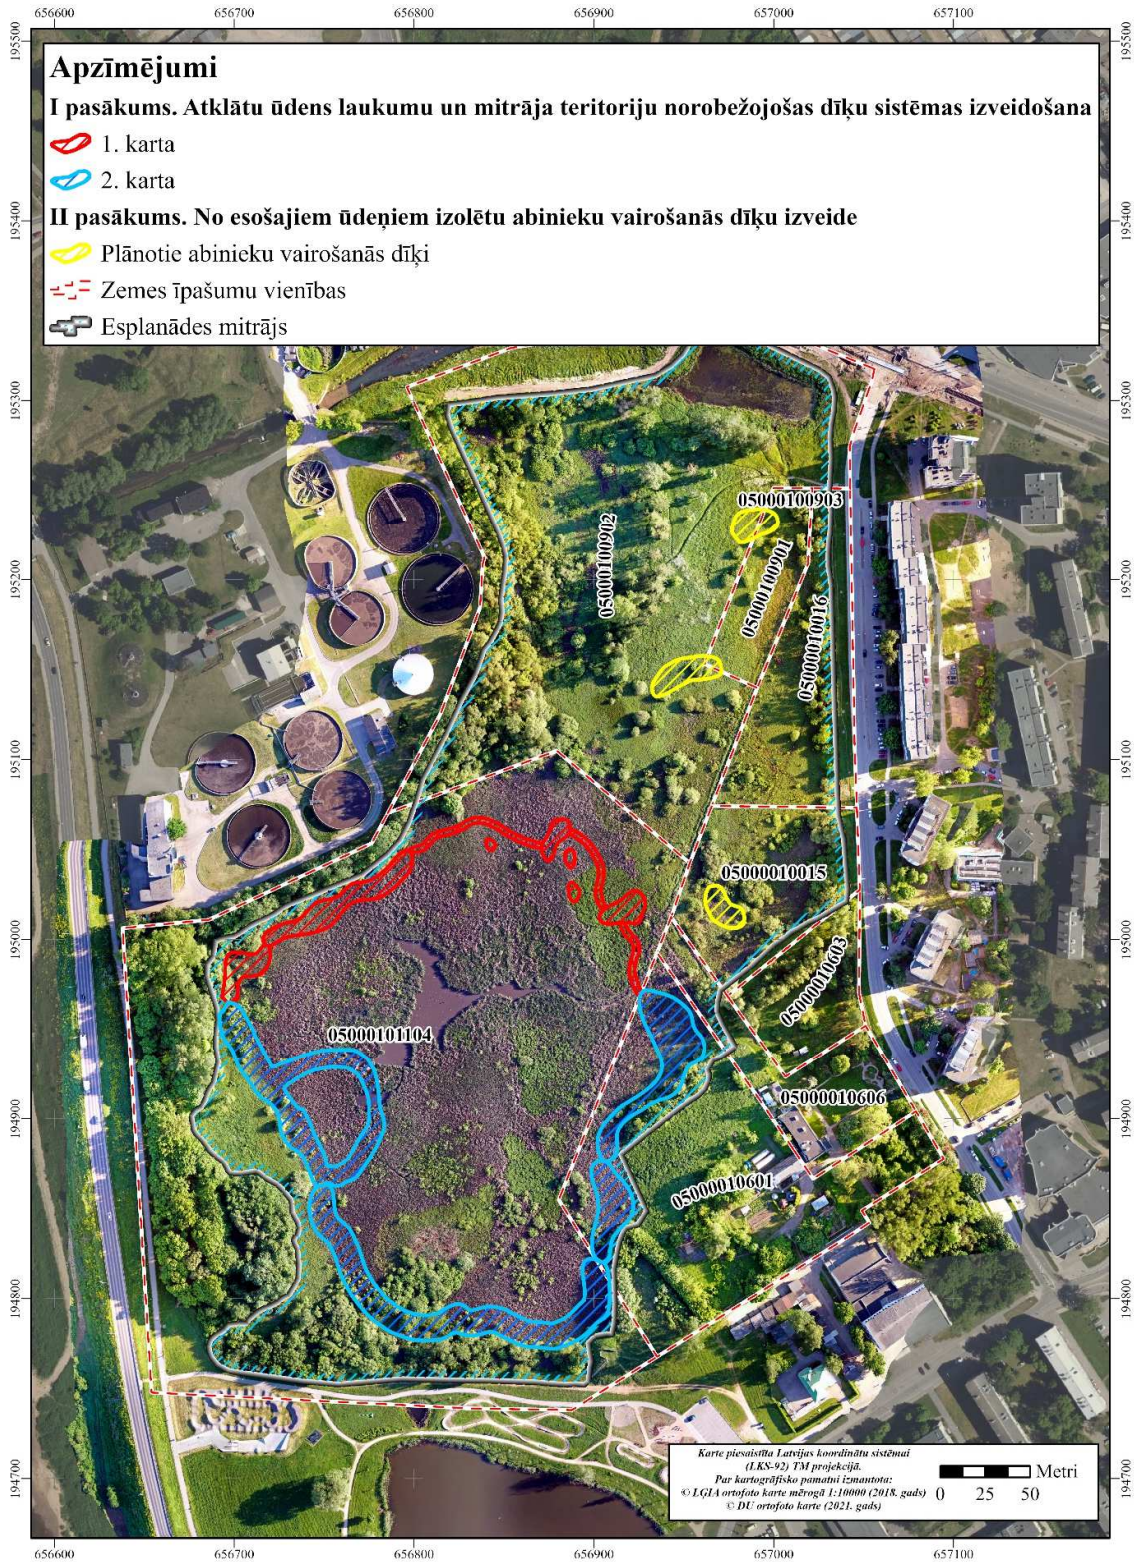
Figure 29. Already implemented (Phase 1) and planned (Phase 2) sites for the creation of open water areas and a pond system enclosing the site, as well as for the creation of amphibian breeding sites

If the creation of pond/canal system planned in Phase 2 (Figure 29) is implemented, the excavated ponds and canals will form a closed ring of water, thereby reducing the impact of surrounding

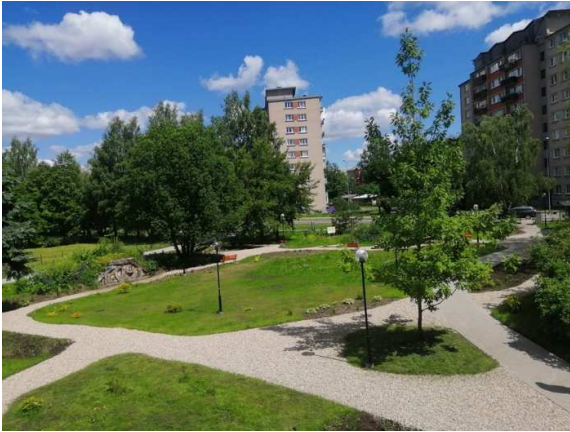
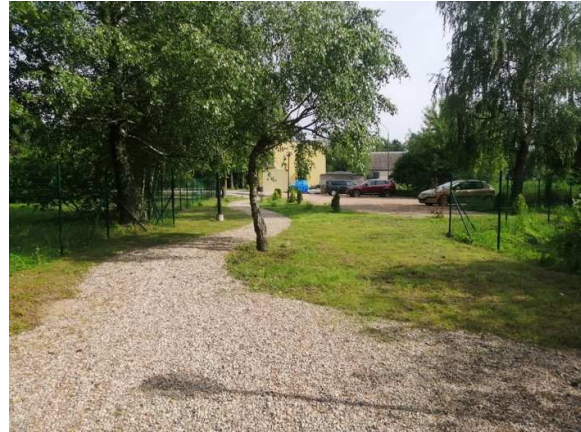
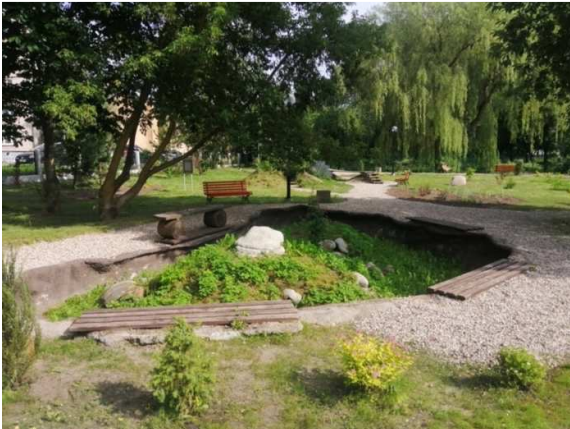
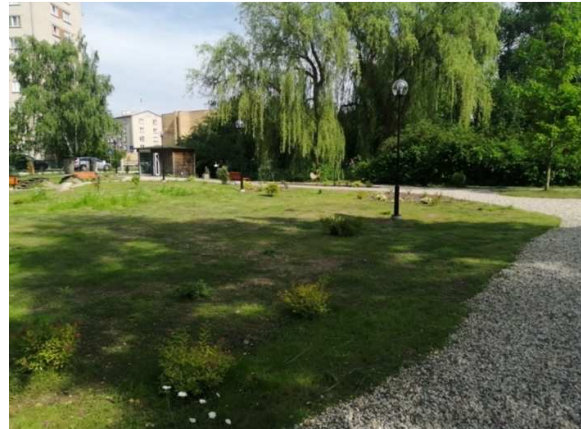
During the implementation of the project, works were carried out to improve the territory of the Latgale Zoo - pavements, entrance roads and pedestrian walkways were arranged, the lawn was landscaped, trees and shrubs were planted (Figures 30, 31, 32 and 33). Benches, waste bins and a bicycle rack have been placed in the area. A video surveillance system and a visitor counter have been installed. During the landscaping the most valuable trees and shrubs were preserved and large green areas were left, they will provide a suitable environment not only for zoo visitors but also for many species of invertebrates, birds and other groups of organisms.

*Figures 30, 31, 32 and 33. Improvement of the Latgale Zoo courtyard area (Photo: A. Rimicāns)*

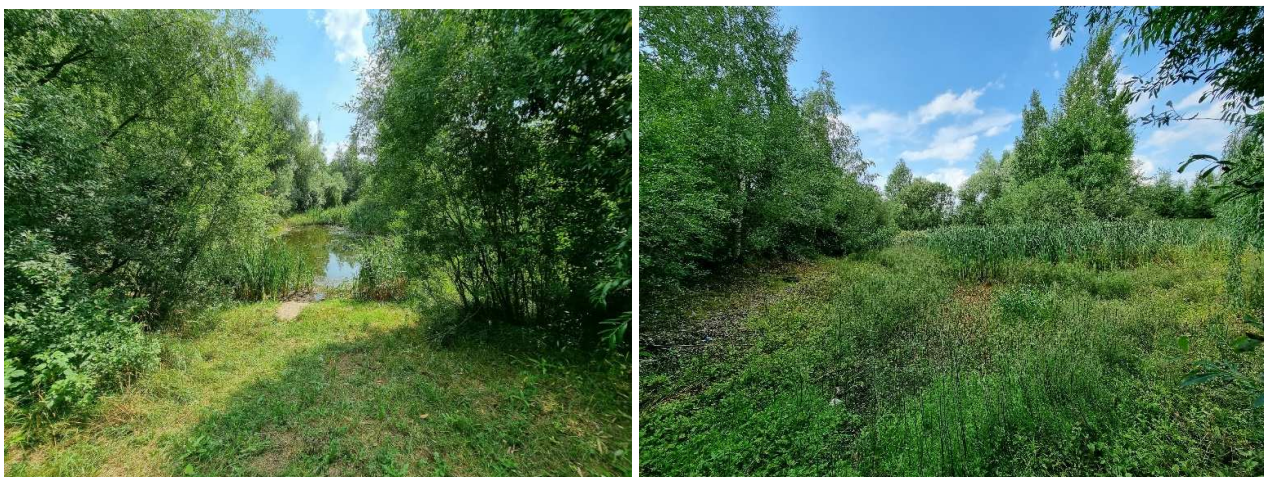
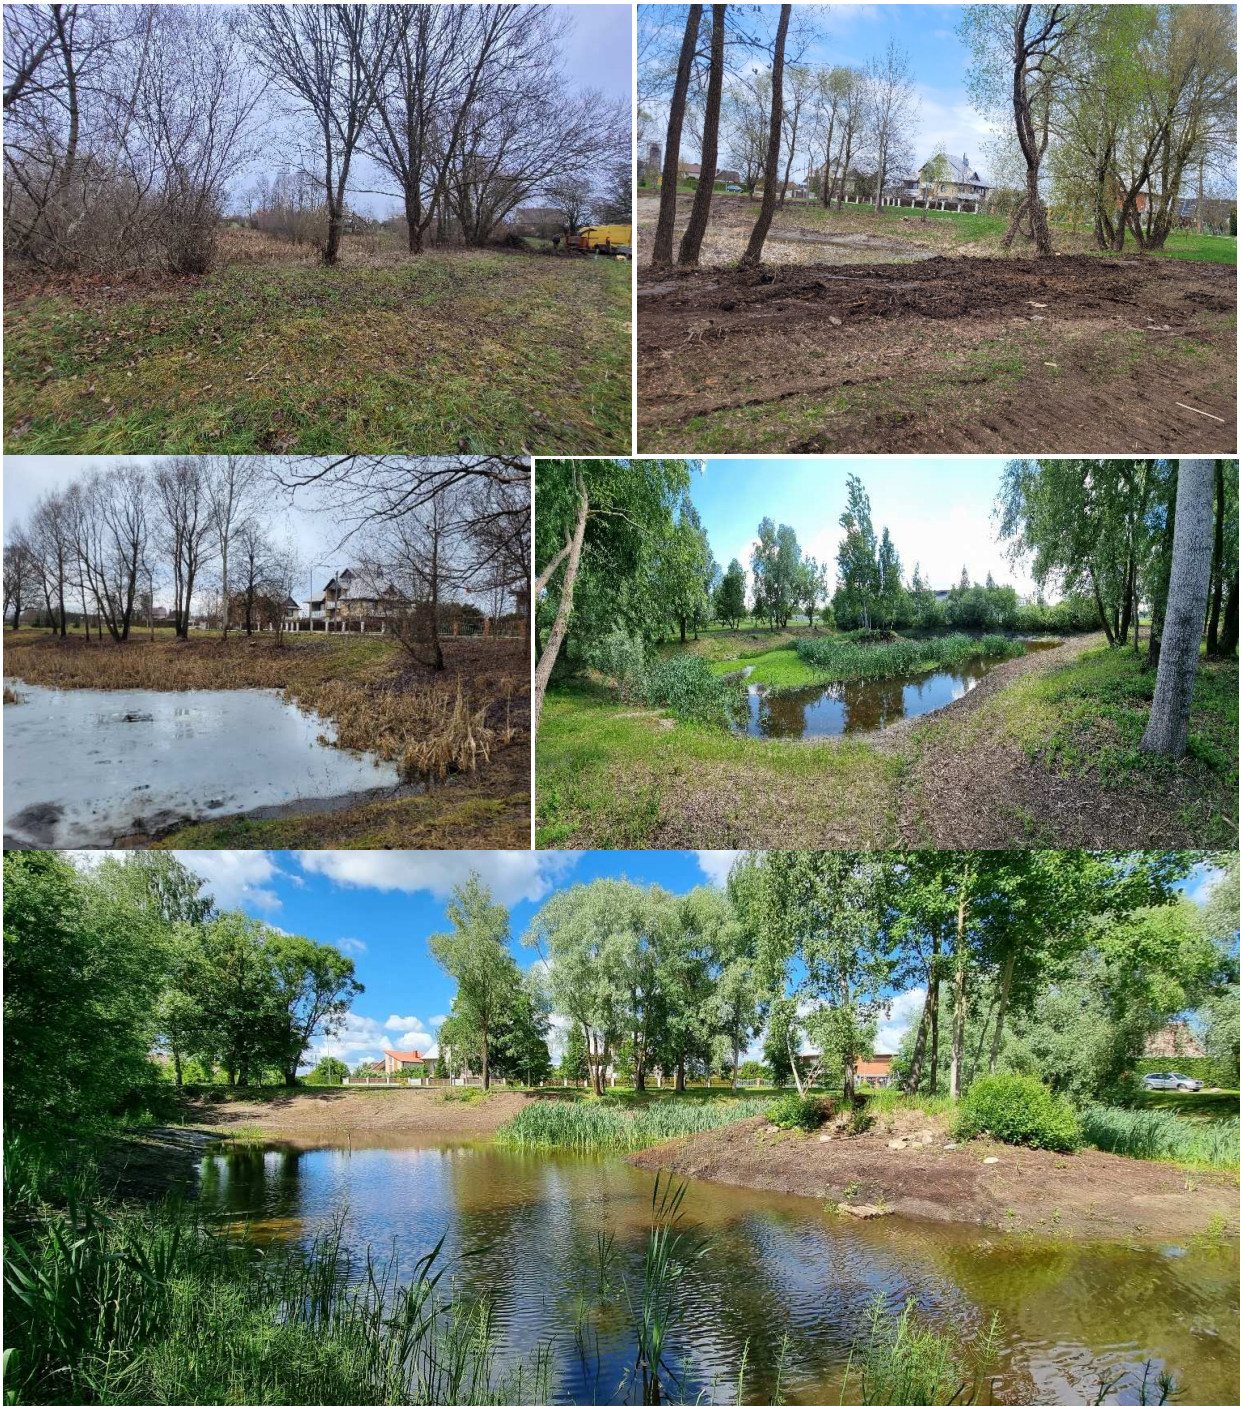
Within the framework of the project, removal of densely overgrown shoots of *Salix caprea* from the shores of the Anykščiai Green pond has been carried out (Figures 34 and 35). Unhealthy and dangerously inclined shoots and branches of other trees (e.g. *Salix fragilis*, *Tilia cordata*) had been also removed. Two individuals of invasive tree species *Acer negundo* had been cut as well. All the valuable trees were left untouched.

Stumps of cut *Salix sp.* scrubs and invasive *Acer negundo* had been removed by excavator during cleaning of the pond (Figures 36, 37, 38, 39 and 40).

*Figures 34, 35, 36, 37, 38, 39 un 40. Anykščiai Green pond before (A) and after (B) scrub removal (Photo: A. Balevičius un E. Abramovaitė)*

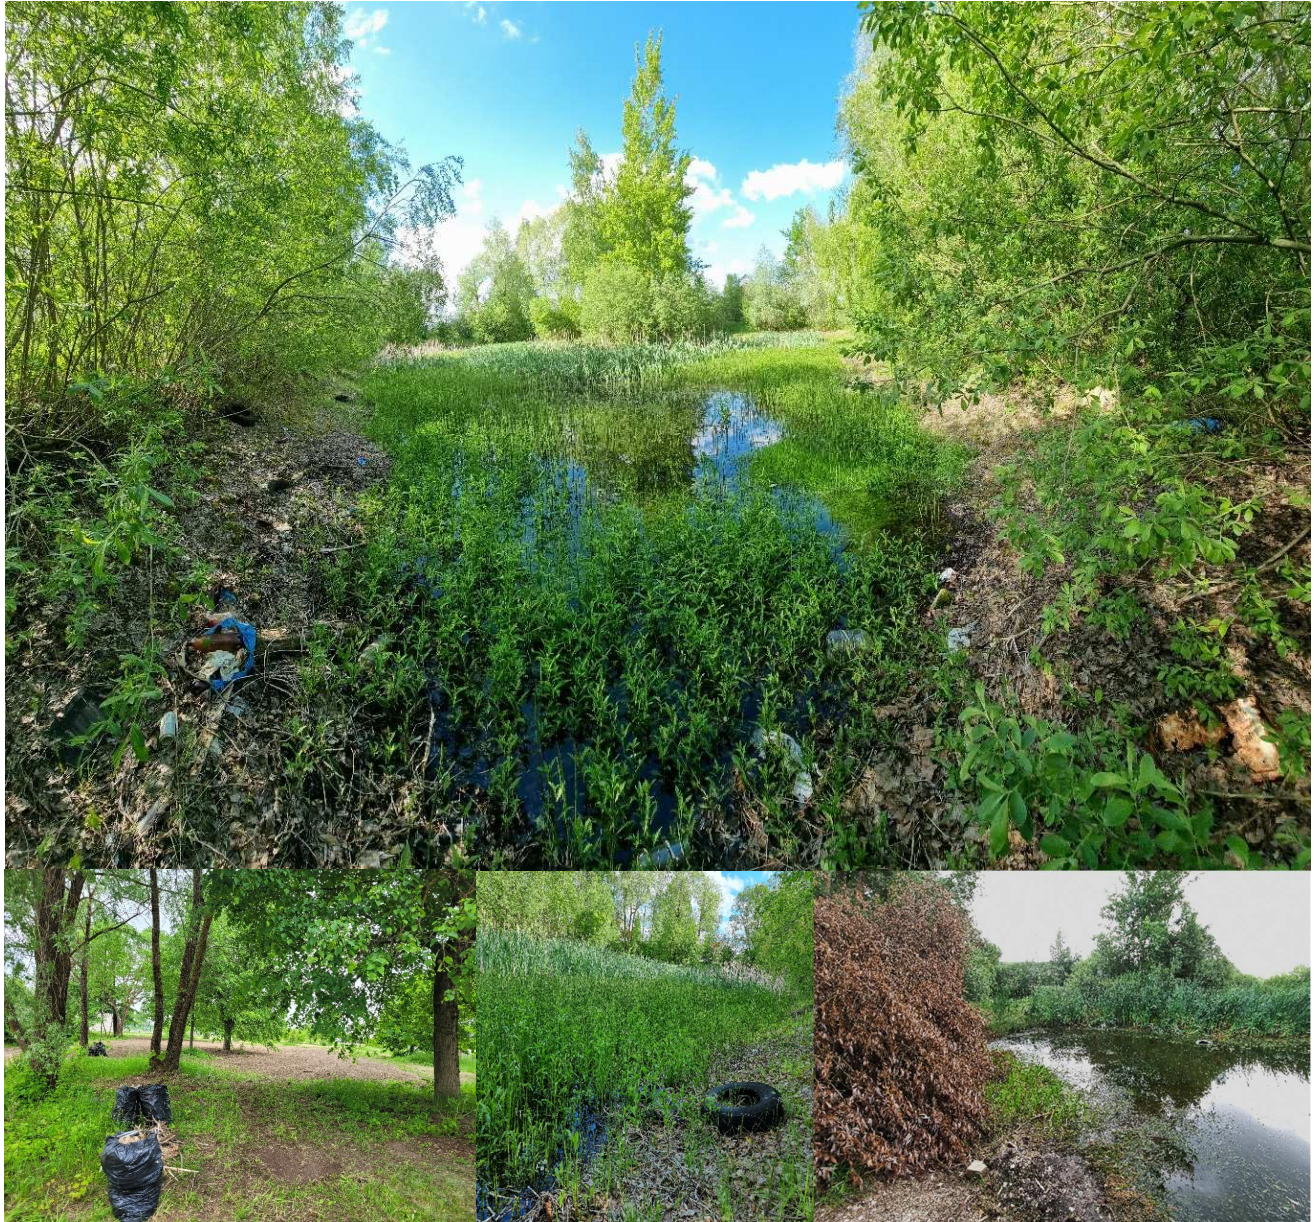
As the territory was abandoned for decade (Figures 41, 42, 43 un 44), a plenty of rubbish had been collected, sorted (glass, plastic metal, green waste) and utilized during the implementation of the project.

*Figures 41, 42, 43 un 44. Territory around the Green pond was polluted by various rubbish which was collected and sorted (Photo: A. Balevičius and E. Abramovaitė)*

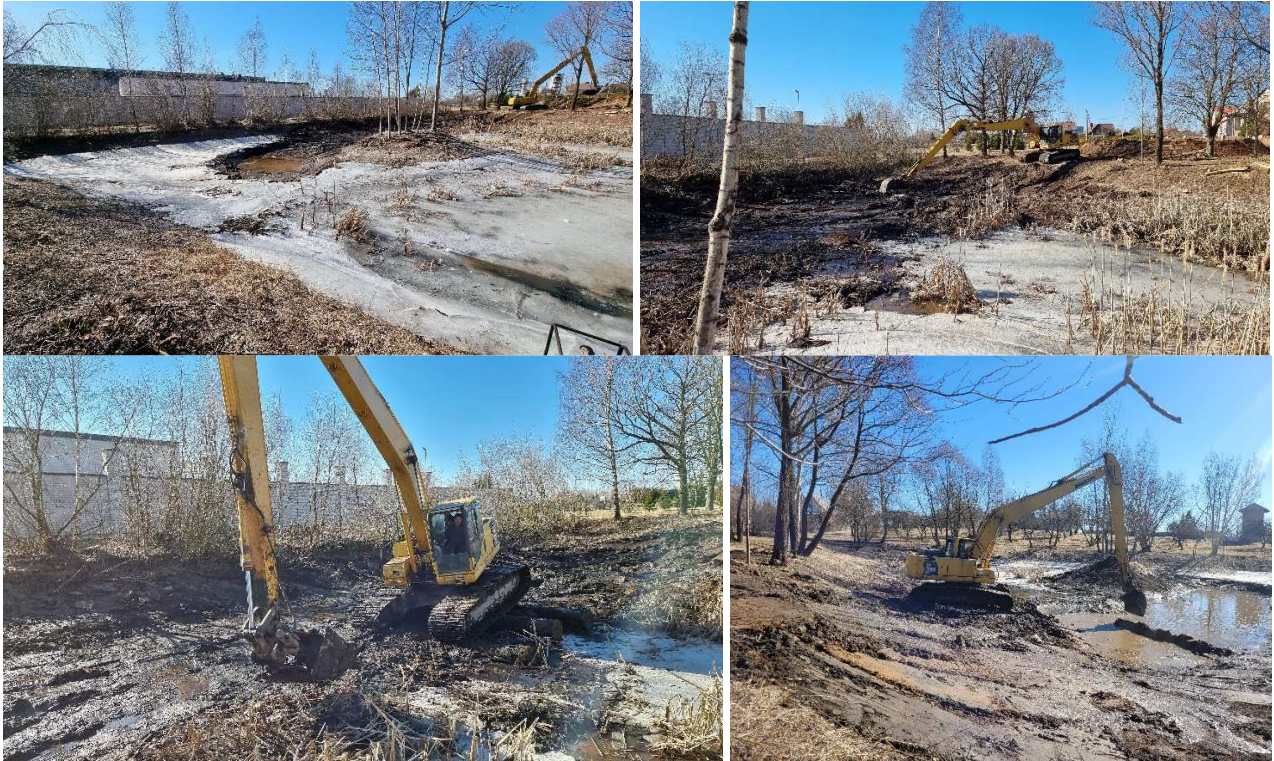
About 2/3 part of the Green pond area was cleaned from accumulated sludge (Figures 45, 46, 47 and 48) and about 10 % of its' area was deepened up to 3 m of water depth in order to prevent deterioration of aquatic ecosystem which occurred because of reconstructed drainage system in the buildings nearby as well as climate change.

*Figures 45, 46, 47 un 48. Cleaning and deepening of the Anykščiai Green pond (Photo: A. Balevičius and E. Abramovaitė)*

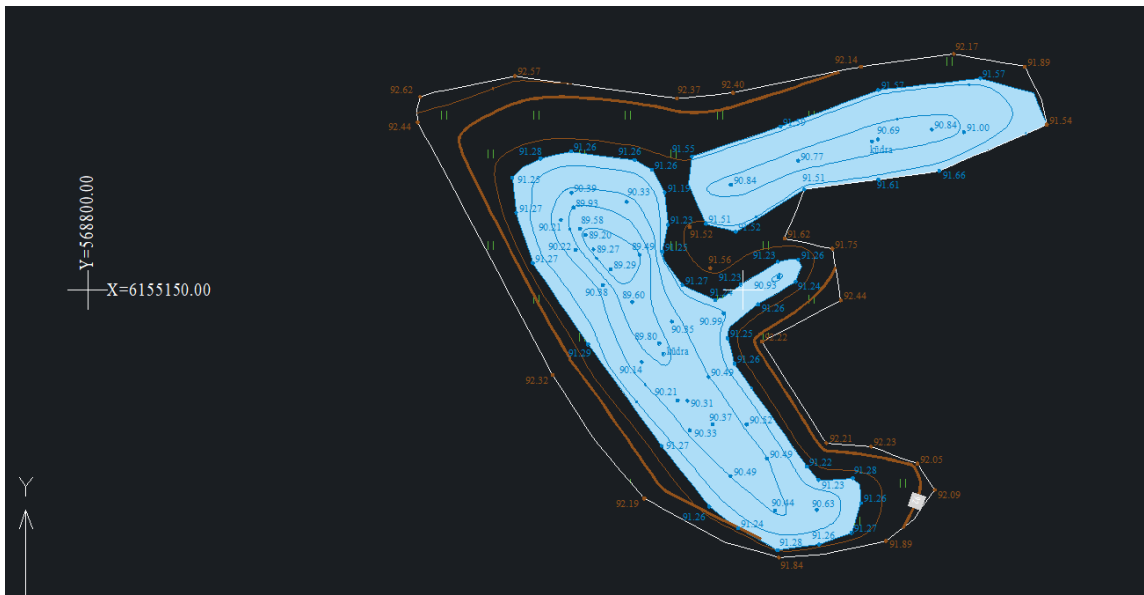
In order to control the quality of excavation jobs, bathymetrical map had been performed after excavating finished (Figure 4).

Figure 49. Bathymetric map of the Green pond after cleaning and deepening

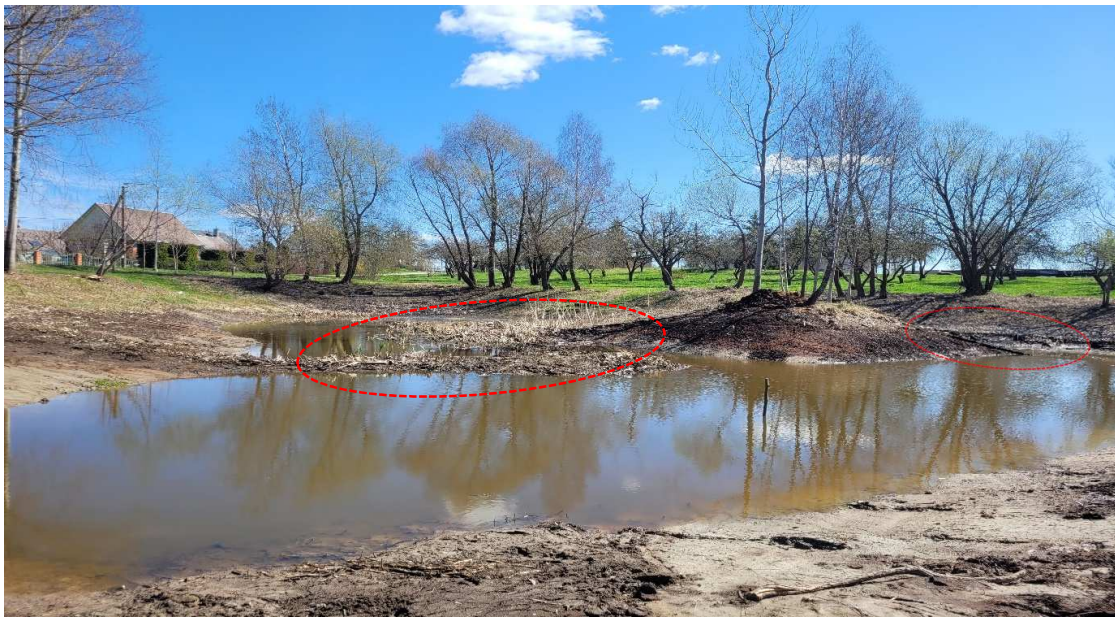
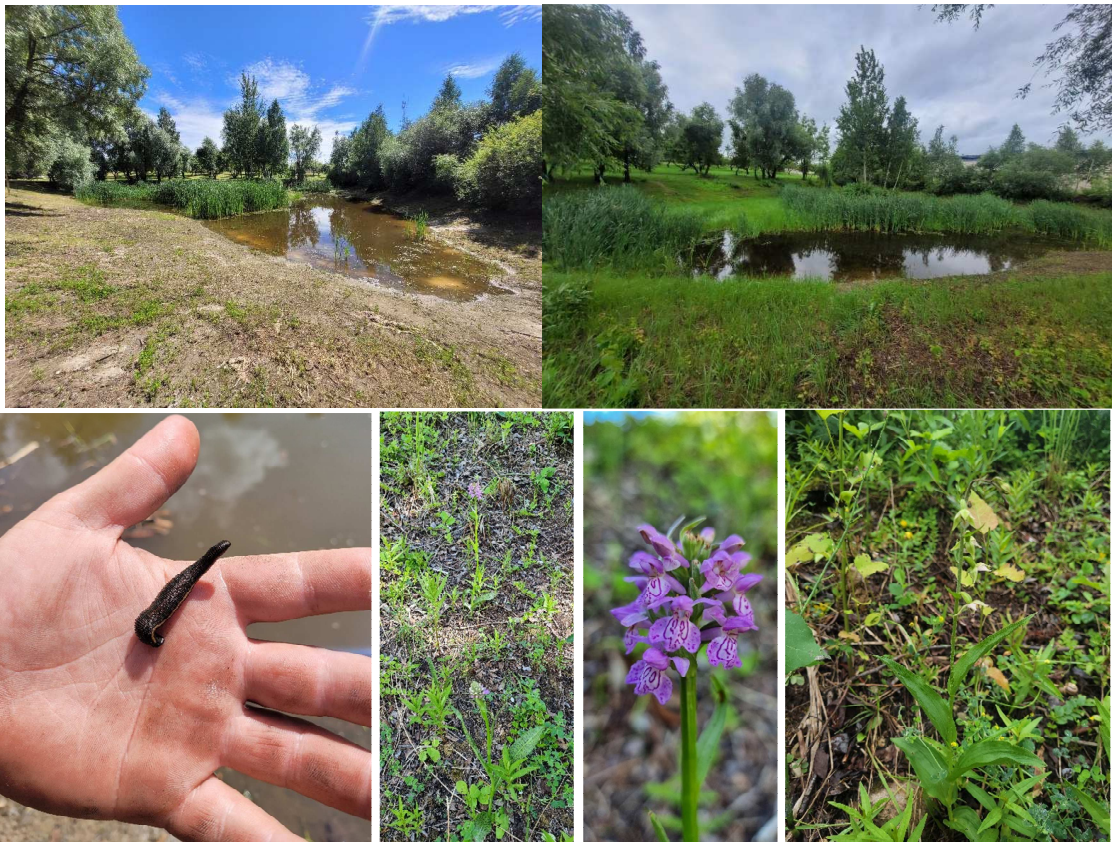
As some rare and protected species were found in the Green pond, the other part (about 1/3) of the pond was left untouched in order to sustain rare species habitats. This step was successful – all the rare species survived during pond cleaning and were monitored in summer 2022 (Figures 50, 51, 52, 53, 54, 55 and 56). It looks like changes in scrub density positively affected population of *Dactylorhiza maculata* – 19 flowering specimens of this species were calculated in the Eastern shore of the Green pond. There were 8 specimens flowering in 2021. Further monitoring of rare species must be performed.

*Figures 50, 51, 52, 53, 54, 55 and 56. Part of the Green pond was left uncleaned in order to sustain biodiversity and habitats of protected species (Photo: A. Balevičius un E. Abramovaitė)*

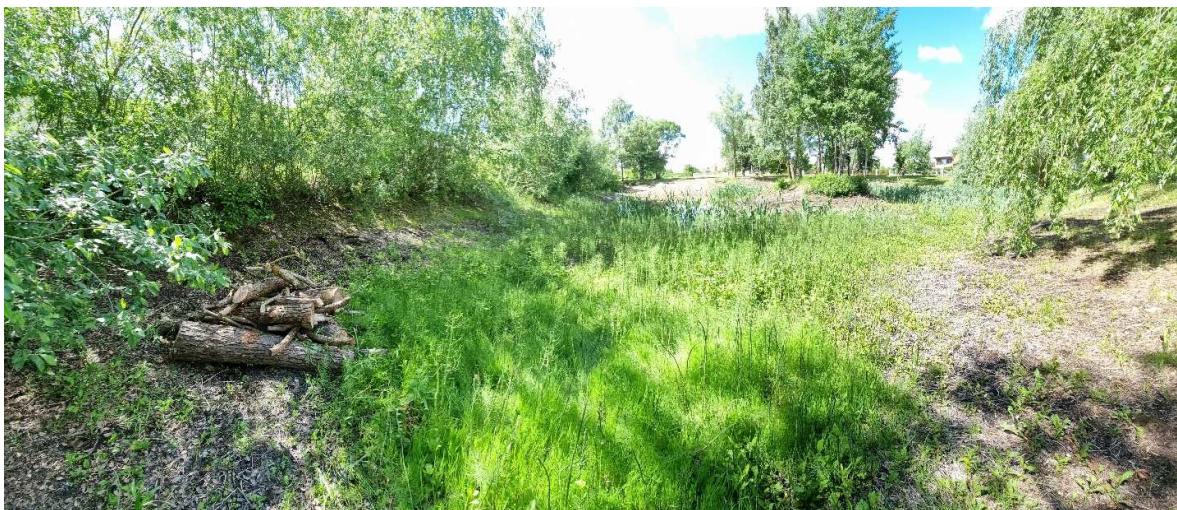
Shelters for amphibians and reptilians were made from locally cut timber (Figure 57). They had been installed in wet but non-floodable places.

*Figure 57. Artificial shelters for reptiles were made from cut Salix tree trunks (Photo: A. Balevičius)*

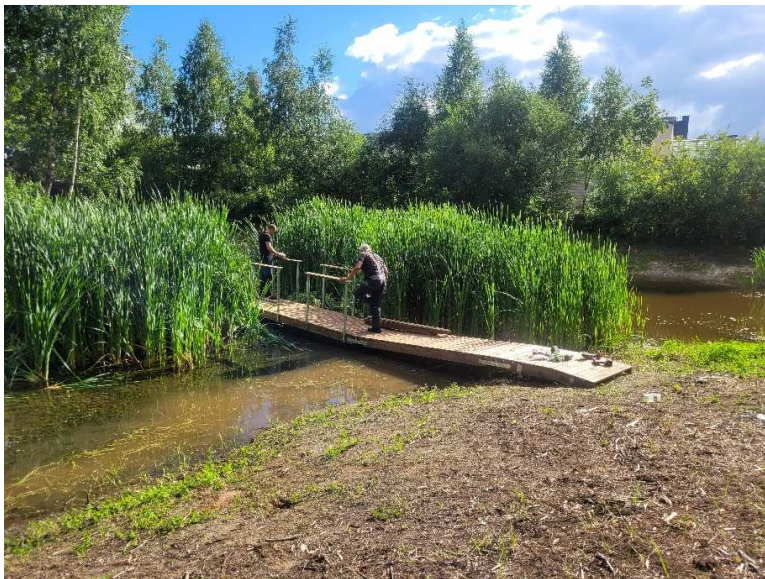
Area of the Green pond is compact, easily accessible, making it convenient to observe the animals and plants that live there. Architectural solutions of pathways, ponton foot-bridge, benches, information stands and other details of small architecture were elaborated by the architects of Anykščiai municipality. Ponton foot bridge was installed in summer 2022 (Figure 58).

Figure 58. Ponton foot-bridge connects the pond shore with a small isle inside it (Photo: E. Abramovaitė)
