# Recommendations for further management of the natural and landscape values of the Esplanade wetland

Dr. geol. **Juris SOMS**,  
Daugavpils University,  
Faculty of Natural Sciences and Mathematics

## Joint Management of Urban Wetland Areas in border region Latvia-Lithuania. (Urb-Area)

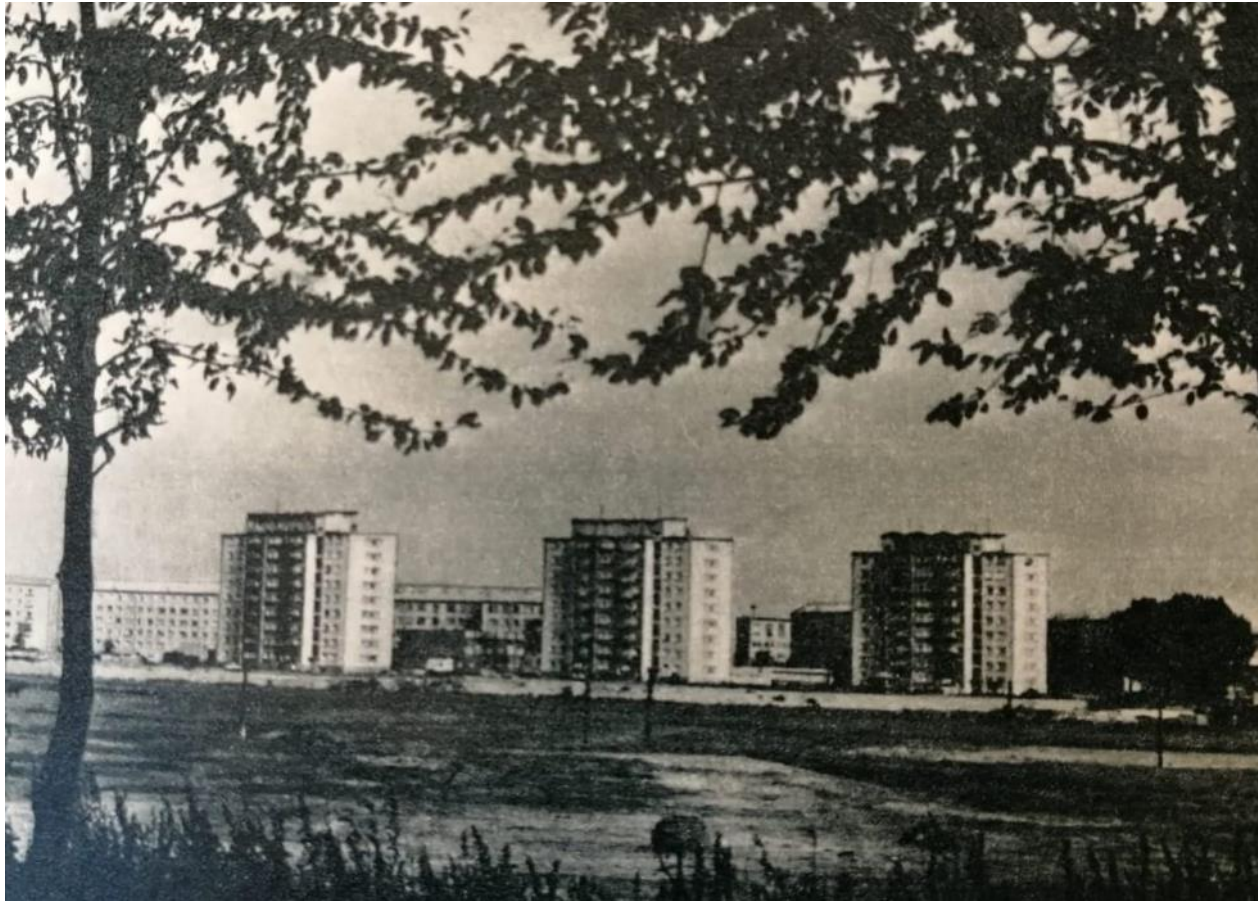
Drained hay meadows in place of the existing Esplanāde wetland (1975)

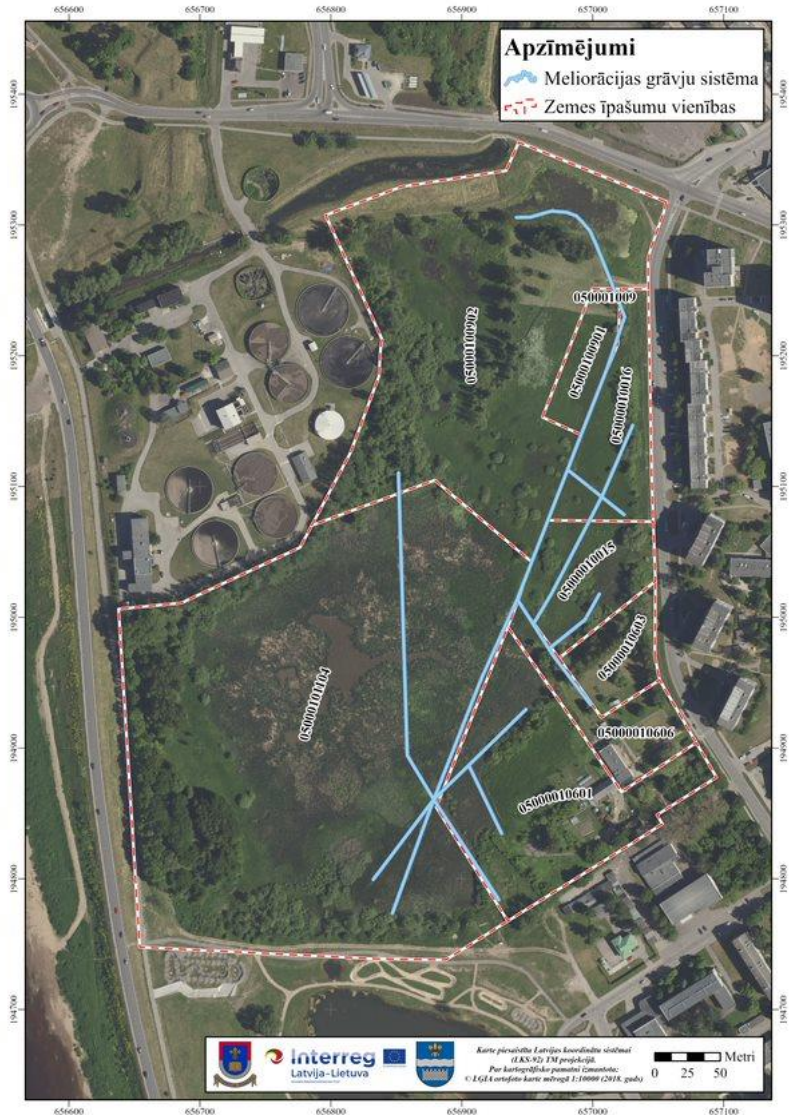
Map of the drainage system in Esplanāde wetland area

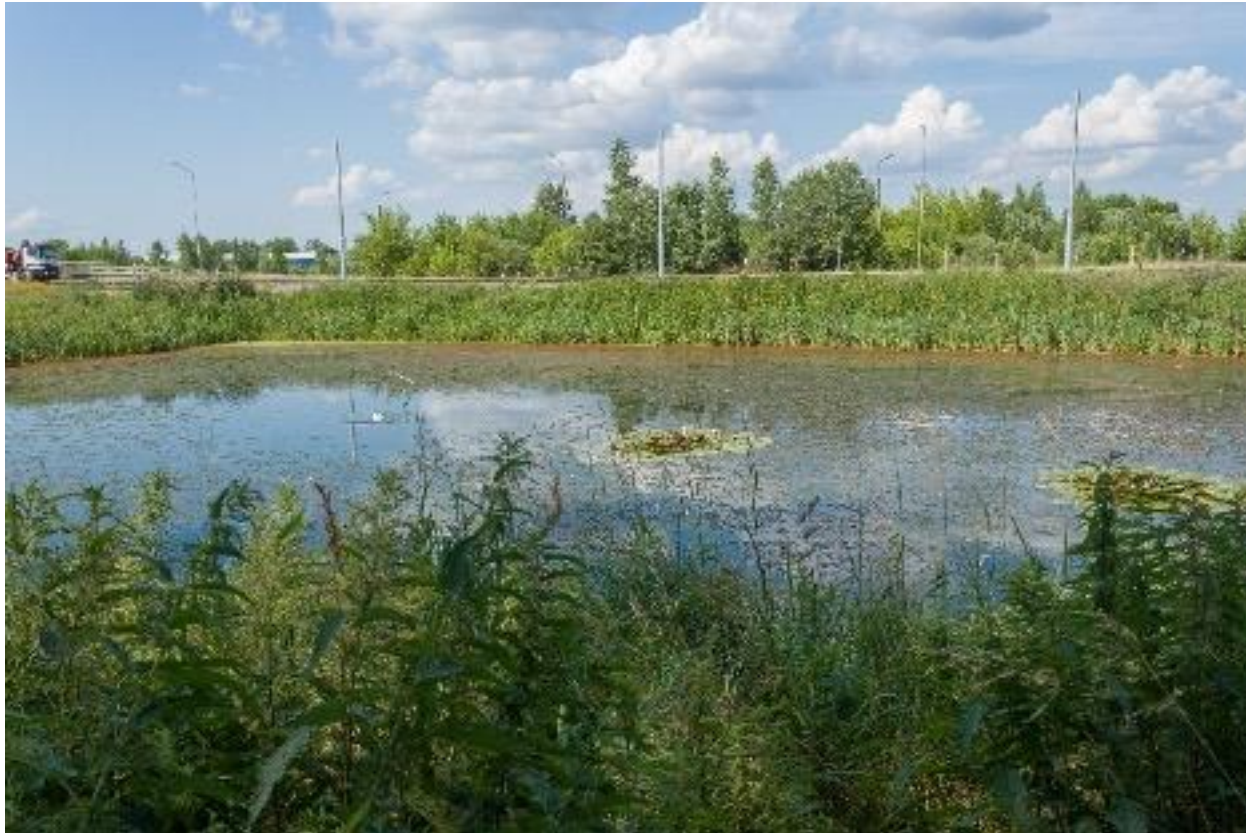
Exavated extension of Šuņupe on the north of the Esplanade wetland area  
(Photo: Karīna Dukule – Jekušenoka)

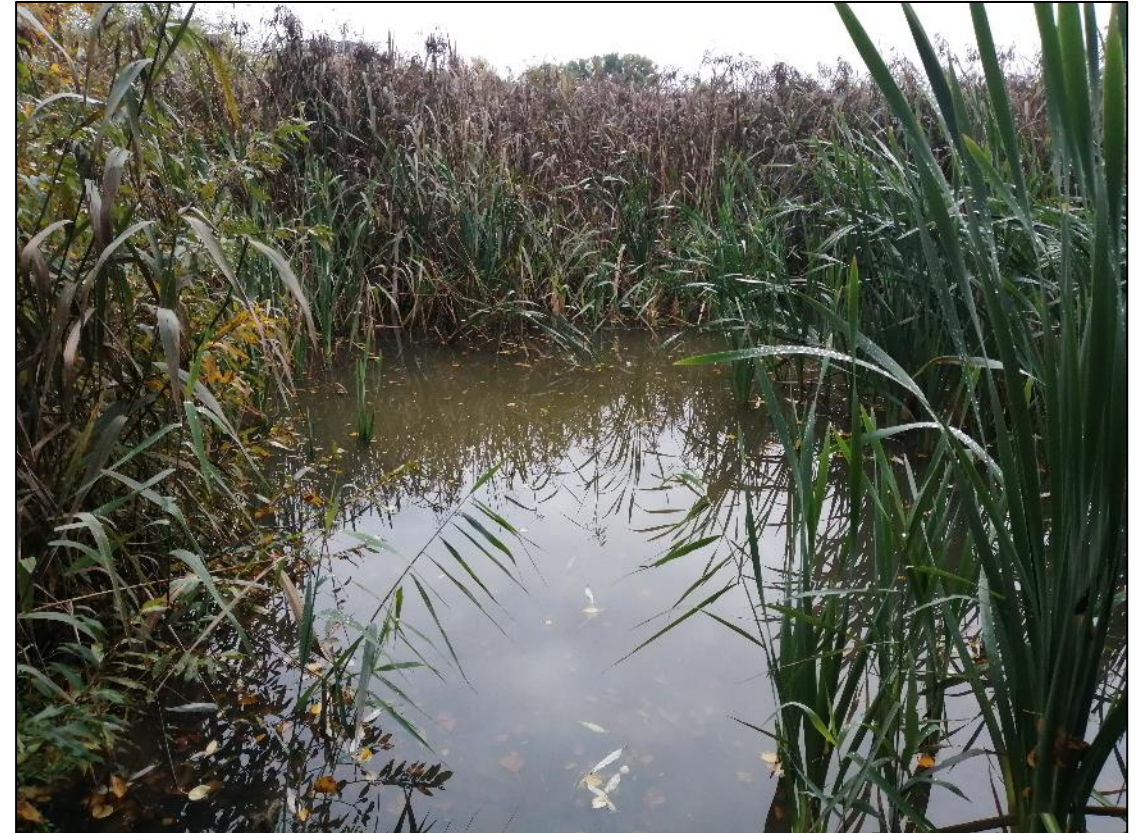
Some of drainage system elements are still functioning  
(Photo: D. Krasnopoļska)

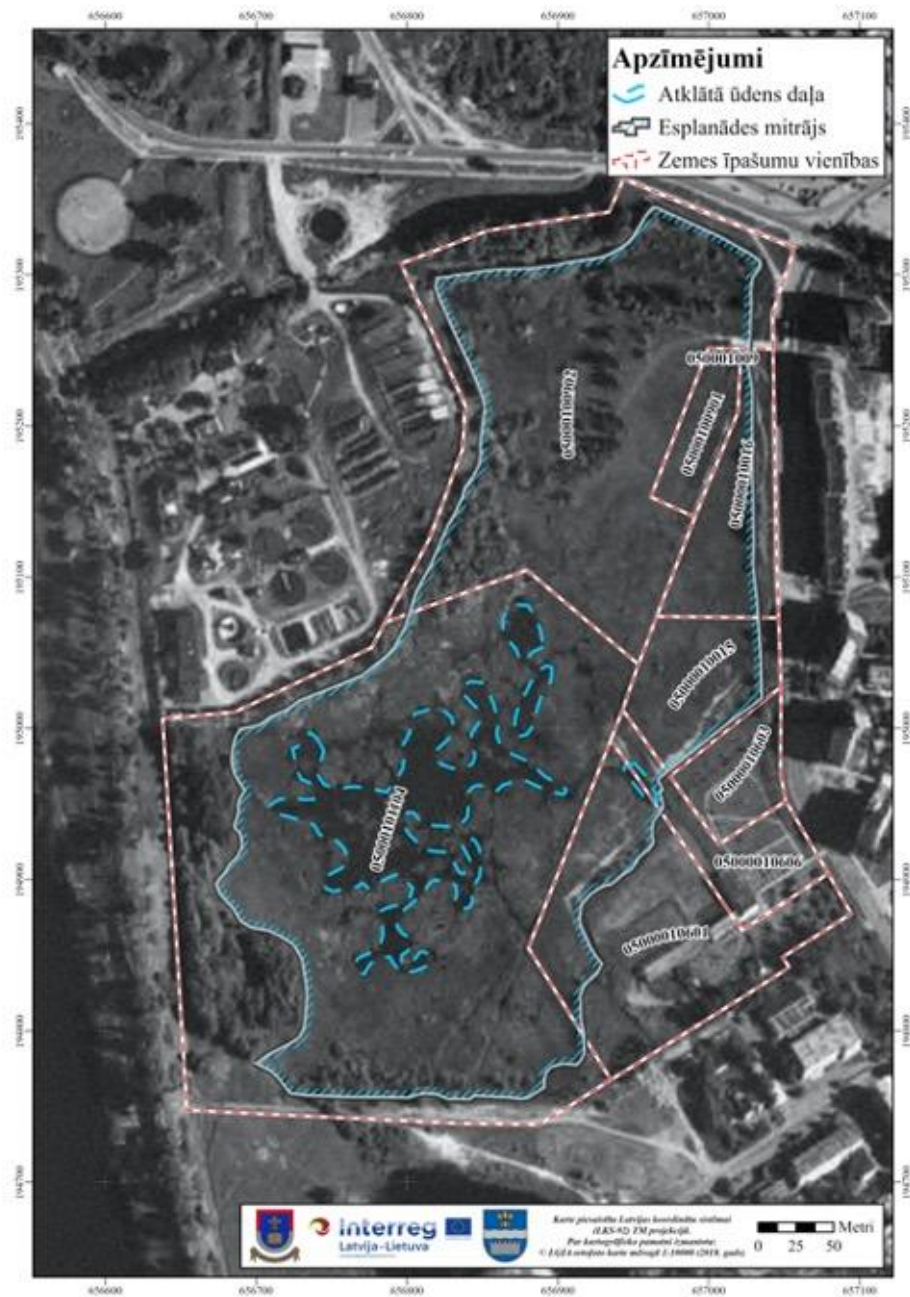
Open water area in Esplanāde wetland in 1995

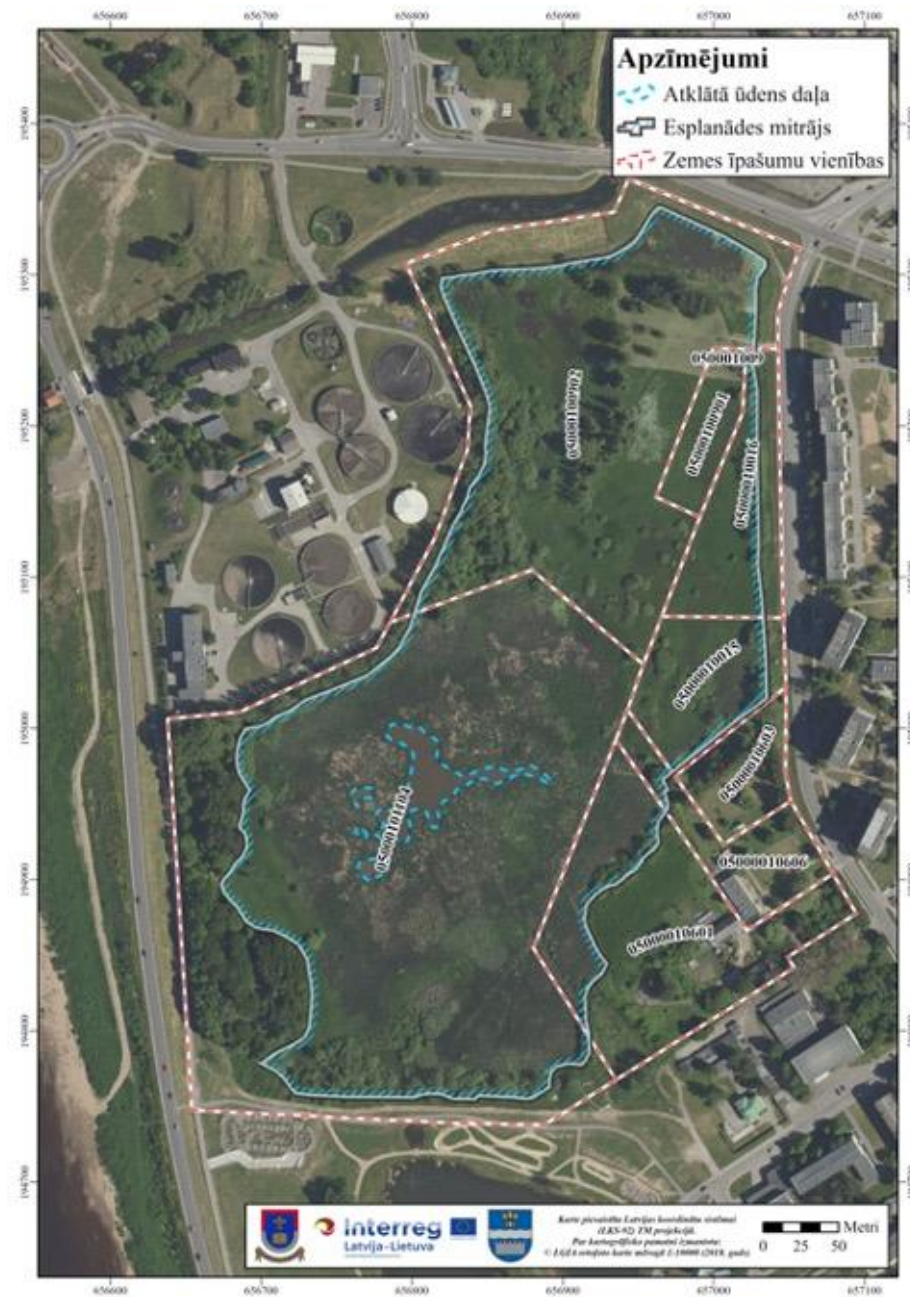
Open water area in Esplanāde wetland in 2017

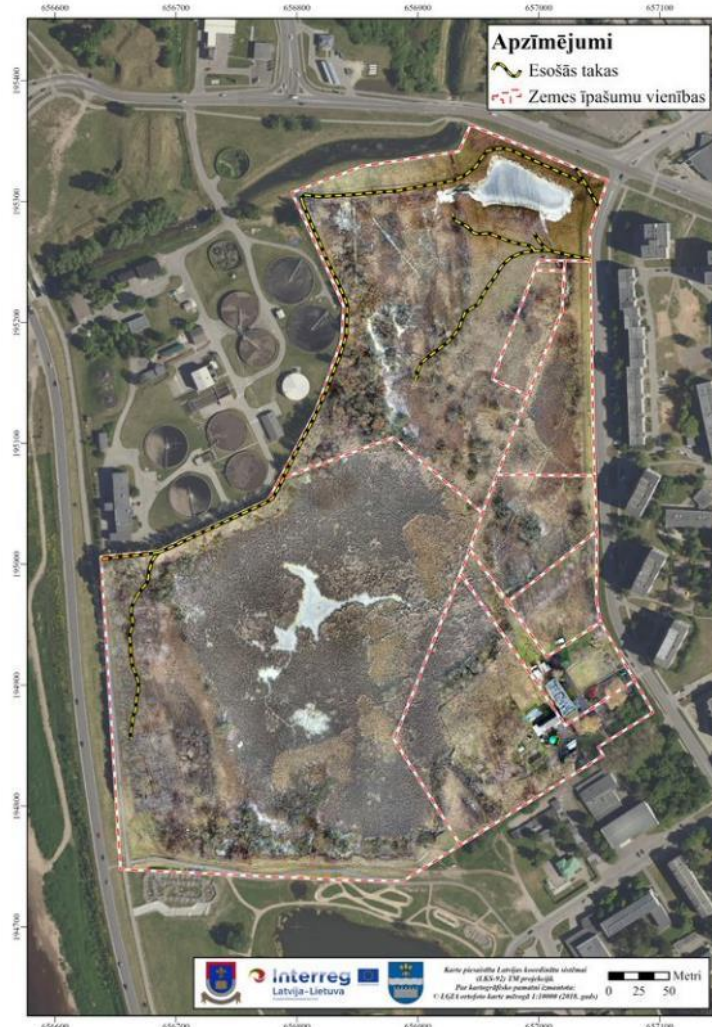
Map of existing trodden trails in Esplanade wetland

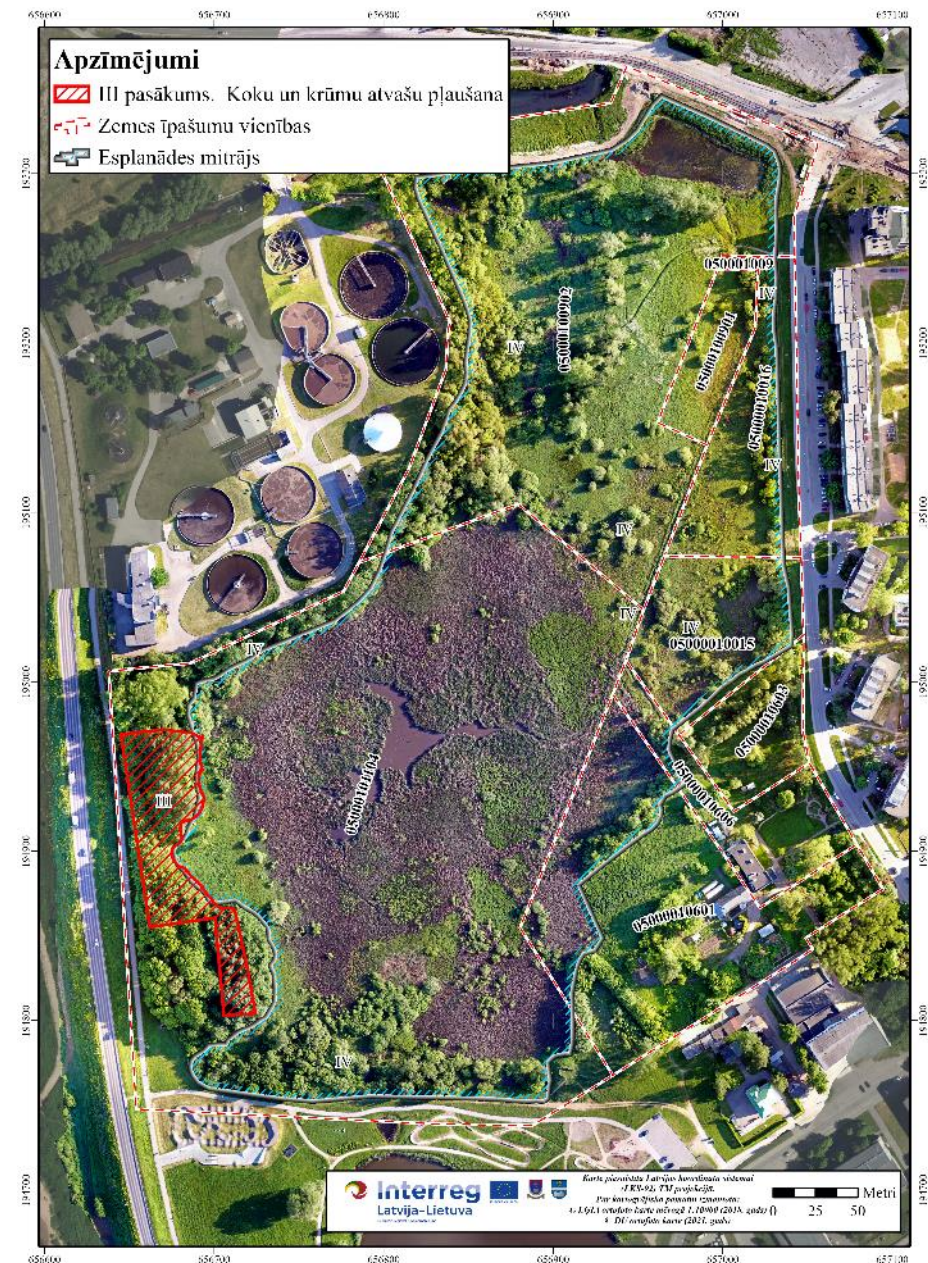
The total area of the territory where mowing shoots of trees and bushes must be implemented is 0.51 ha. The mowing of the shoots is planned to be completed this autumn.

Planned place of implementation of management action

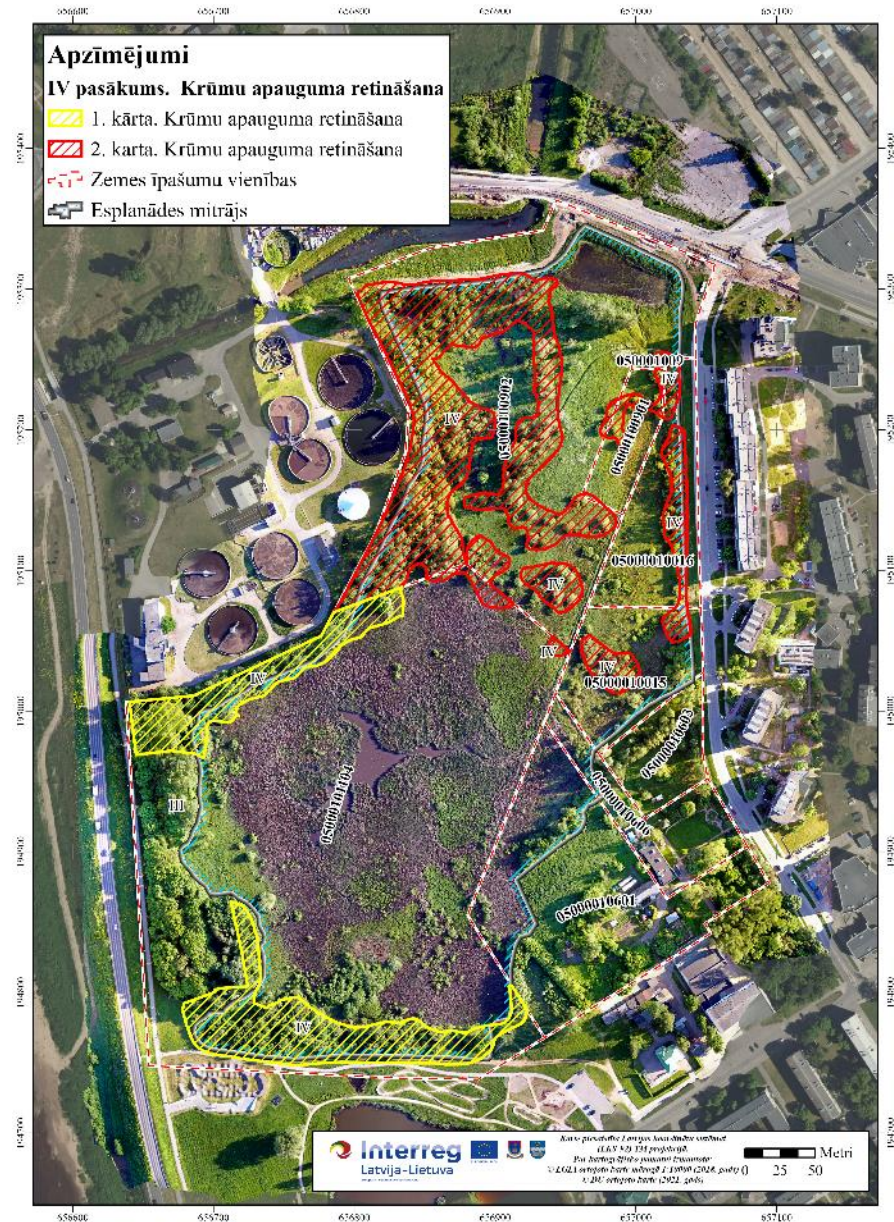
Taking into account the isolation of the territory from other natural territories, the implementation of the specific management measure is planned in two rounds in order to reduce the impact on the animal species inhabiting the bushes. In the 1st round it is planned to implement works in the amount of 1.86 ha, but in the 2nd round - in the amount of 2,53 ha.

Planned places of implementation of management action

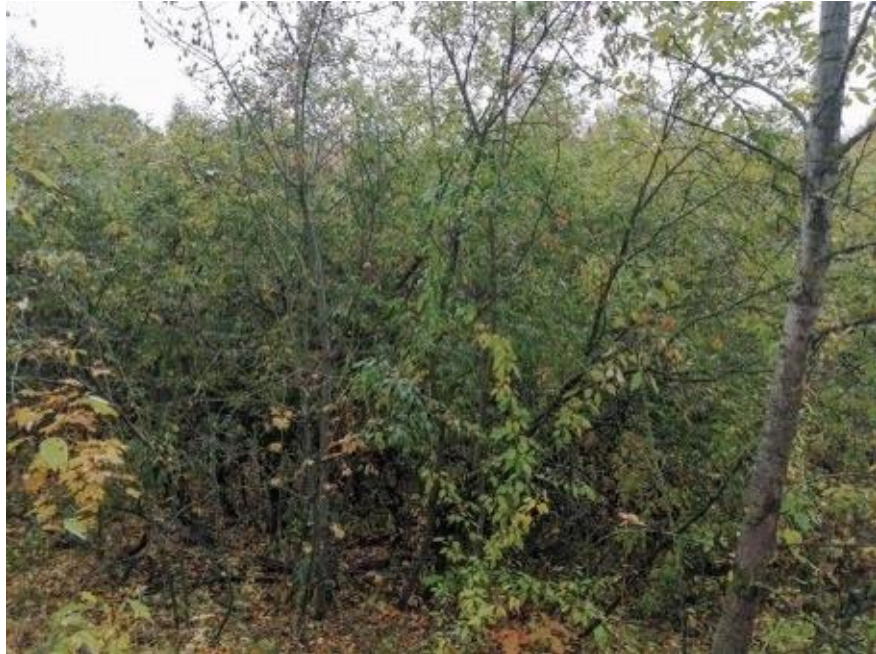
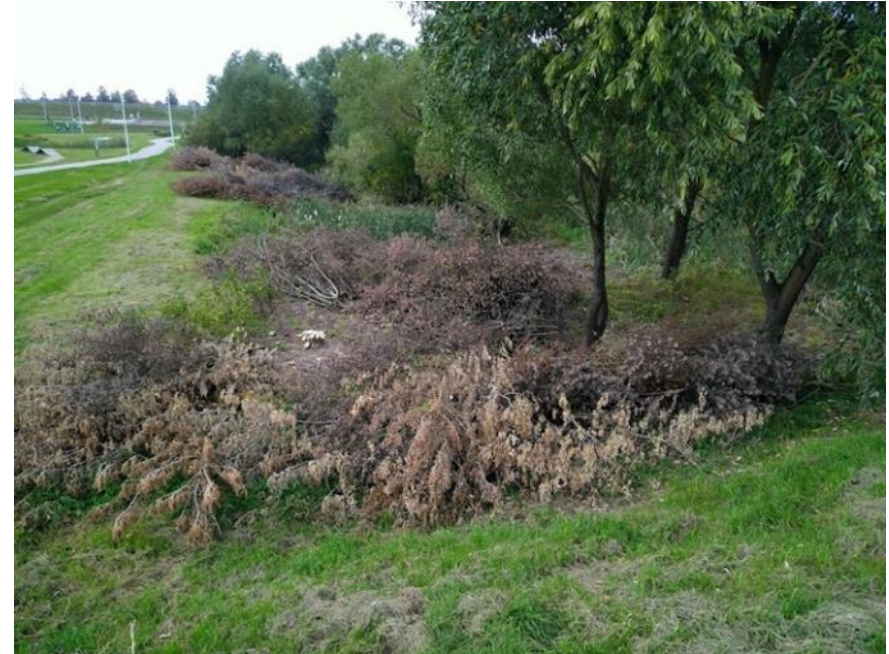
Wetland area adjacent to the Esplanade Park before and after thinning of shrubs

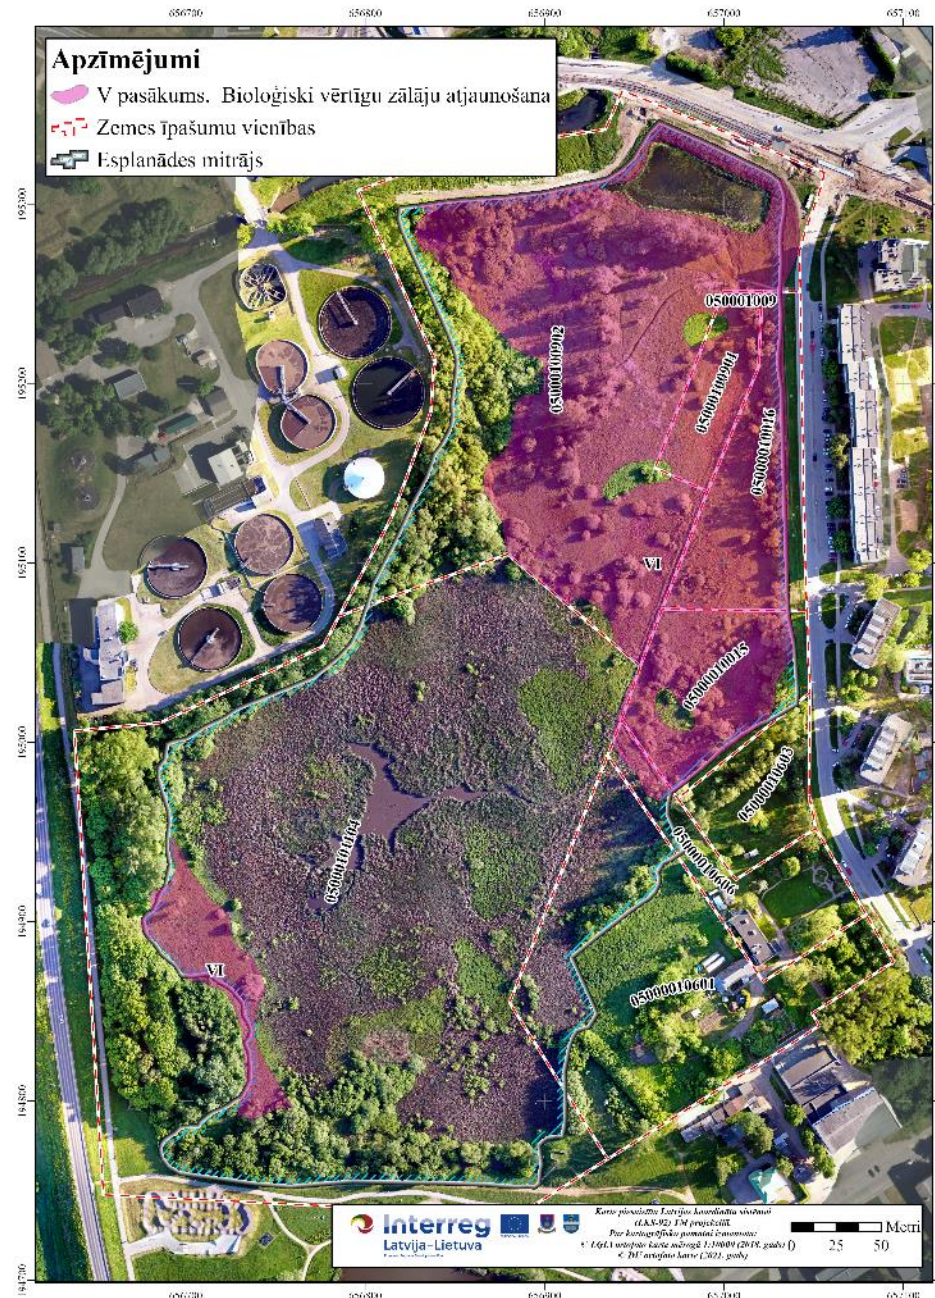
The existing site of the Esplanade wetland, as well as the adjacent area, has grasslands that were once used for haymaking, so the grasslands have a high restoration potential. The total area where grassland restoration is planned is 5.8 ha.

Planned places of implementation of management action

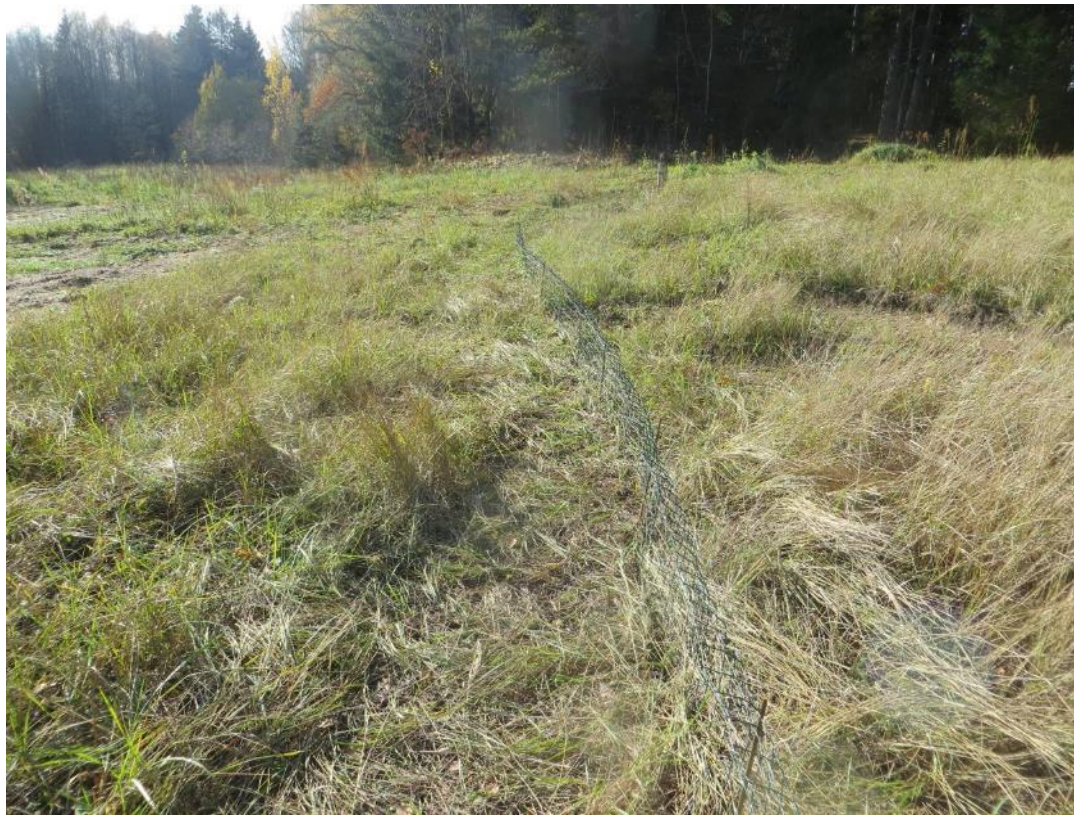
Sample of amphibian/reptile protection fence - an example from the adjacent territory of amphibian breeding ponds established in the vicinity of DU Study and Research Center "Ilgas" (Photo: M. Pupiņš)

In order to reduce the mortality of amphibians and juveniles of birds on the roads in the vicinity of the wetland, it is necessary to create protective fences in the areas defined on the map.

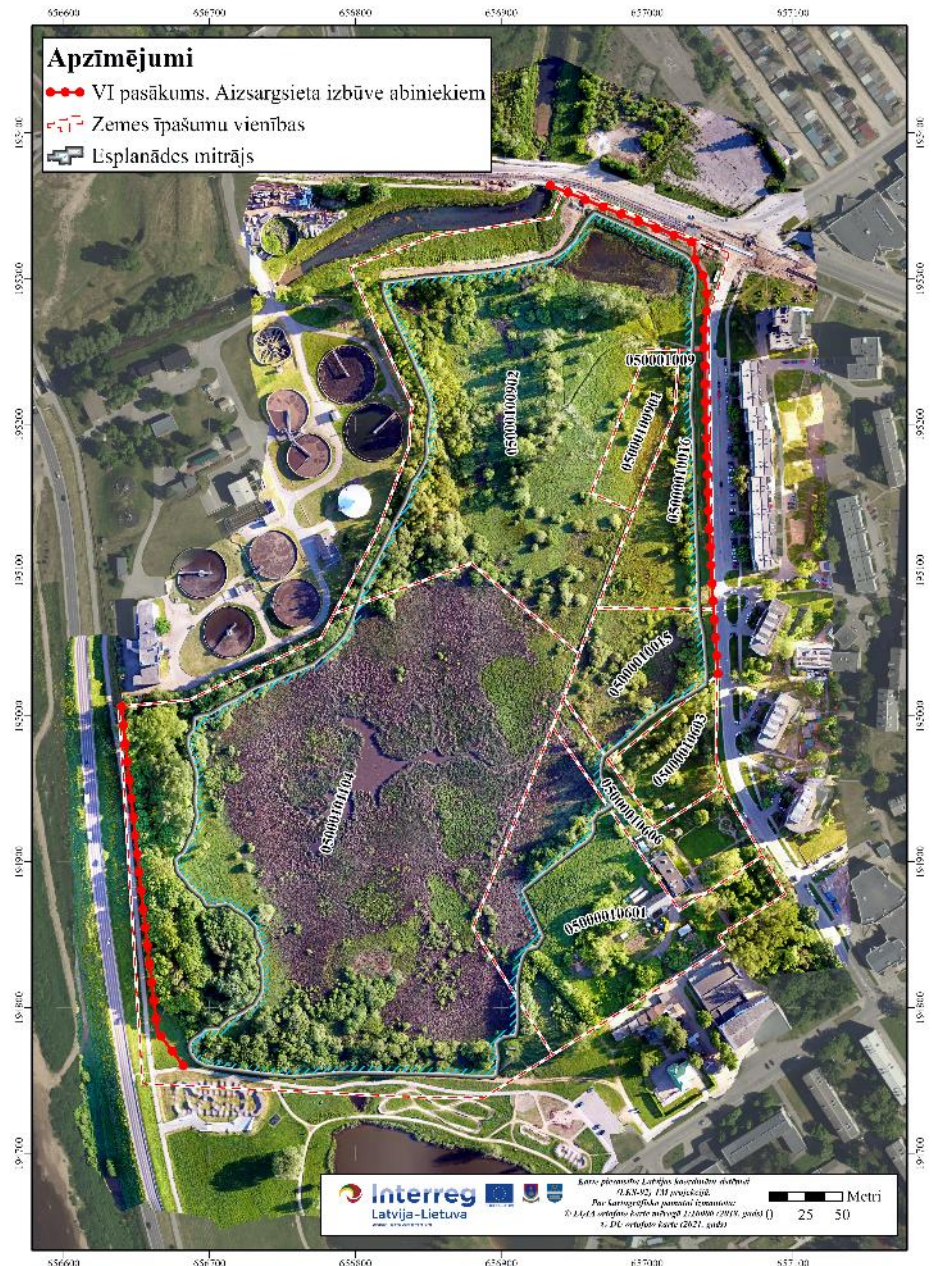
Planned places of implementation of management action

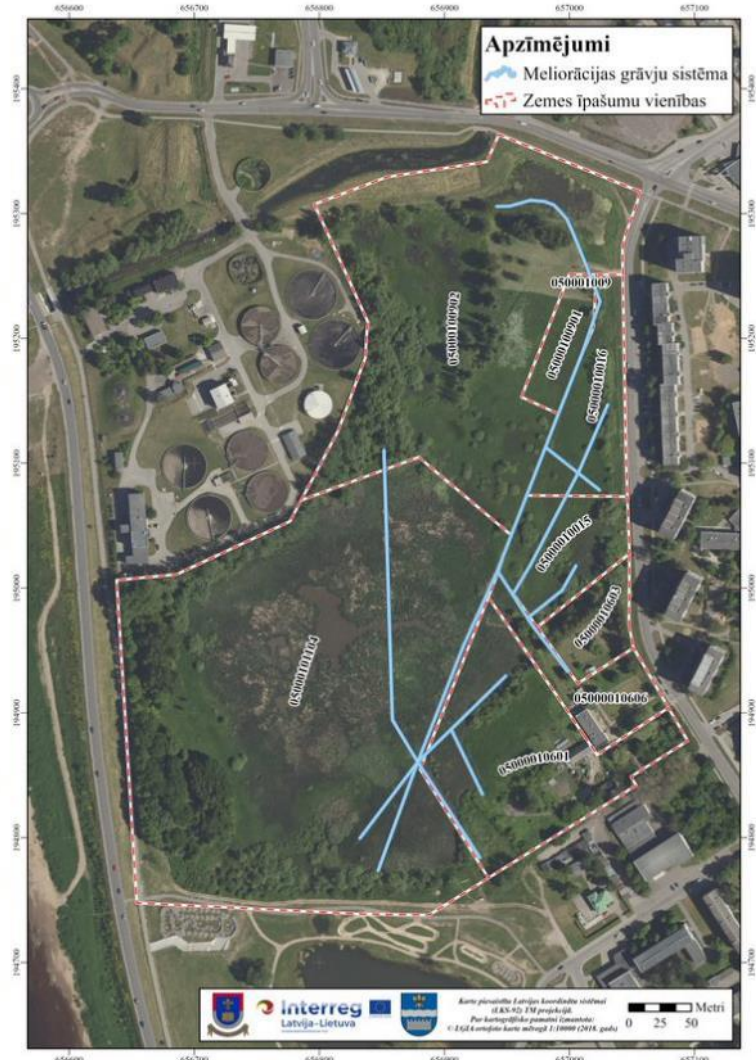
- ✓ One of the possible solutions for ensuring a constant water level in the wetland and the planned pond system is the construction of dams on ditches in the northern part of the wetland.
- ✓ Before the development of the technical project, it is necessary to ensure the monitoring of seasonal changes in the hydrological regime of the territory.

Map of the drainage system in Esplanāde wetland area
